# FALCON *SERVICE BULLETIN ADVISORY*

F900-368

TITLE: **NAVIGATION - ATC - ATC REPLY INHIBIT ON GROUND**

## **FALCON 900**

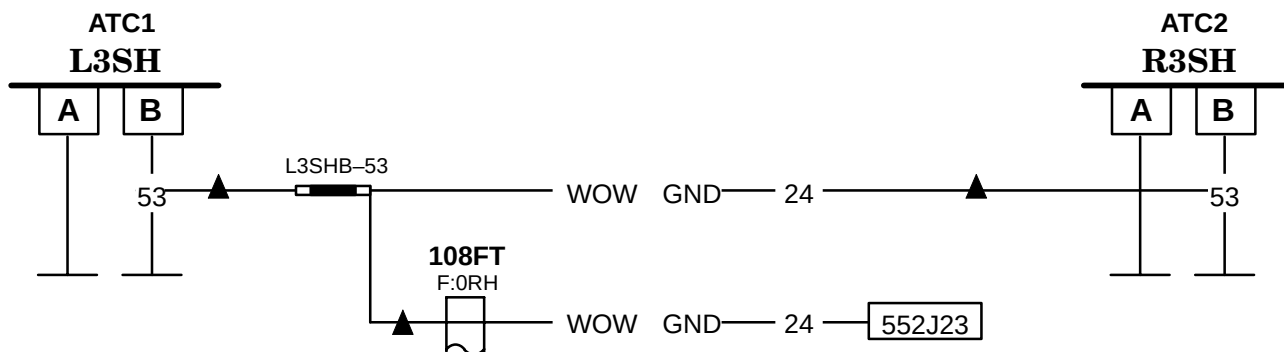
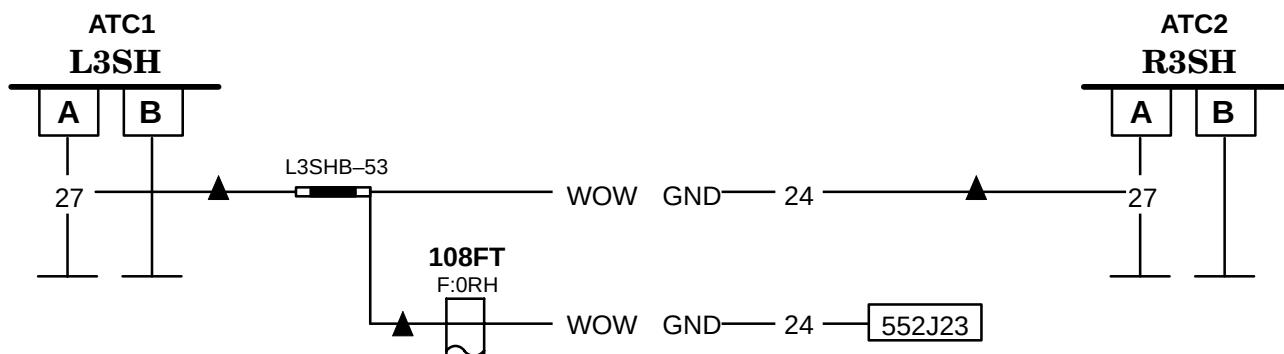
**- FIGURE 1 -**

**A/C < 179 EXCEPT S/N 169**

- (1) Remove ATC 1 (L3SH) and ATC 2 (R3SH) (IPC, chap. 34-50-40, fig. 11, item 40. Gain access to the wiring connected to connectors (L3SHA), (L3SHB), (R3SHA) and (R3SHB).
- (2) Make the electrical modifications in accordance with the diagram in figure 1.

**NOTE:** On each ATC, disconnect #24 gauge wires from terminal 53 of connectors (L3SHB) and (R3SHB) and reconnect them to terminal 27 of connectors (L3SHA) and (R3SHA).
