FALCON SERVICE BULLETIN

FALCON 900

No 411-R1

**FUSELAGE
APU AIR INTAKE
PROTECTION AGAINST FLUID INGESTION
DURING DE-ICING PROCEDURE**

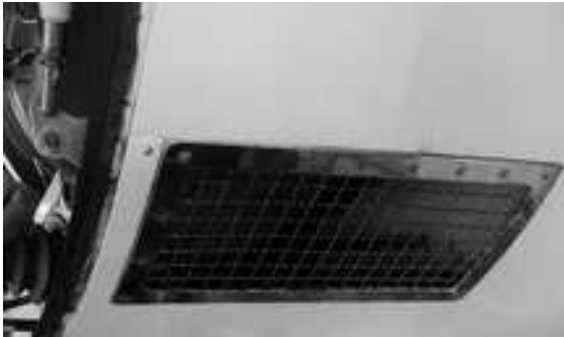
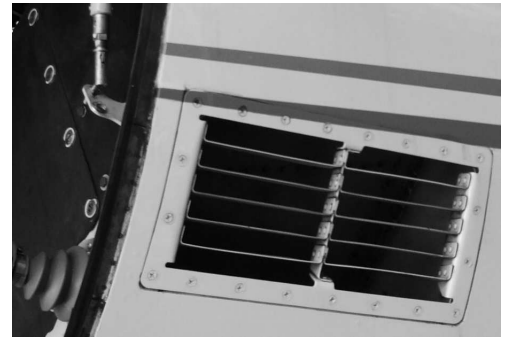
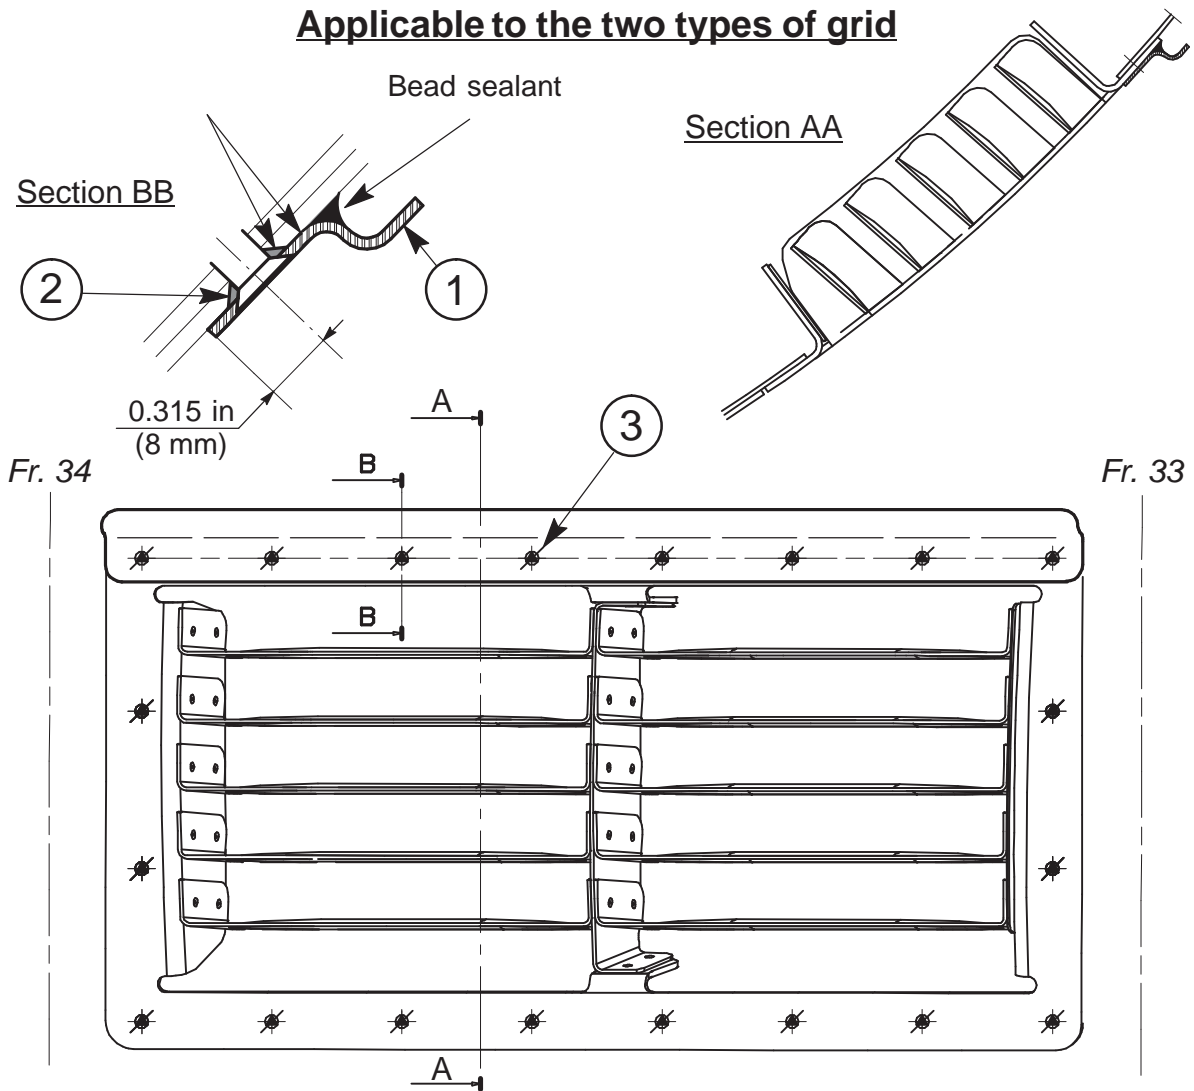
Gutter for APU air intake grid: All A/C
- FIGURE 1 -

Several operators have complained about the ingress of anti-icing product into the APU air inlet, causing passenger complaints due to a bad smell in cabin.

B . INSTALLATION OF THE GUTTER ON THE APU AIR INTAKE (see figure 1)

- (1) Remove the APU air intake grid (see IPC chap. 49-10-00, fig. 01, item 185) taking care not to lose the washers (item 205) if installed.
- (2) Rub the setting surface of the gutter on the APU air intake grid and clean.

- (3) Position the gutter (item 1) on the frame of the grid.
- (4) Counterdrill the eight holes in the gutter to dia. 0.1 in (2.5 mm).
- (5) Enlarge the holes in the gutter to dia. 0.2 in (5.1 mm).

- (6) Set up the tapered washers (item 2) in the countersinking of the eight upper holes of the grid and old the gutter against the APU air intake grid.

- (7) Countersink the holes of the gutter for screws (item 3).
- (8) Sand the countersinking of the eight upper holes of the APU air intake grid.
- (9) Use alodine to protect the countersinking.

- (10) Bond the tapered washers (item 2) in the countersinking of the eight upper holes of the grid using interlaying sealant.
- (11) Install the grid (and the washers item 205 if installed) using only the screws removed for the lower and the side holes.

- (12) Install the gutter with interlaying sealant using the new screws (item 3). Apply a bead of sealant on the gutter.

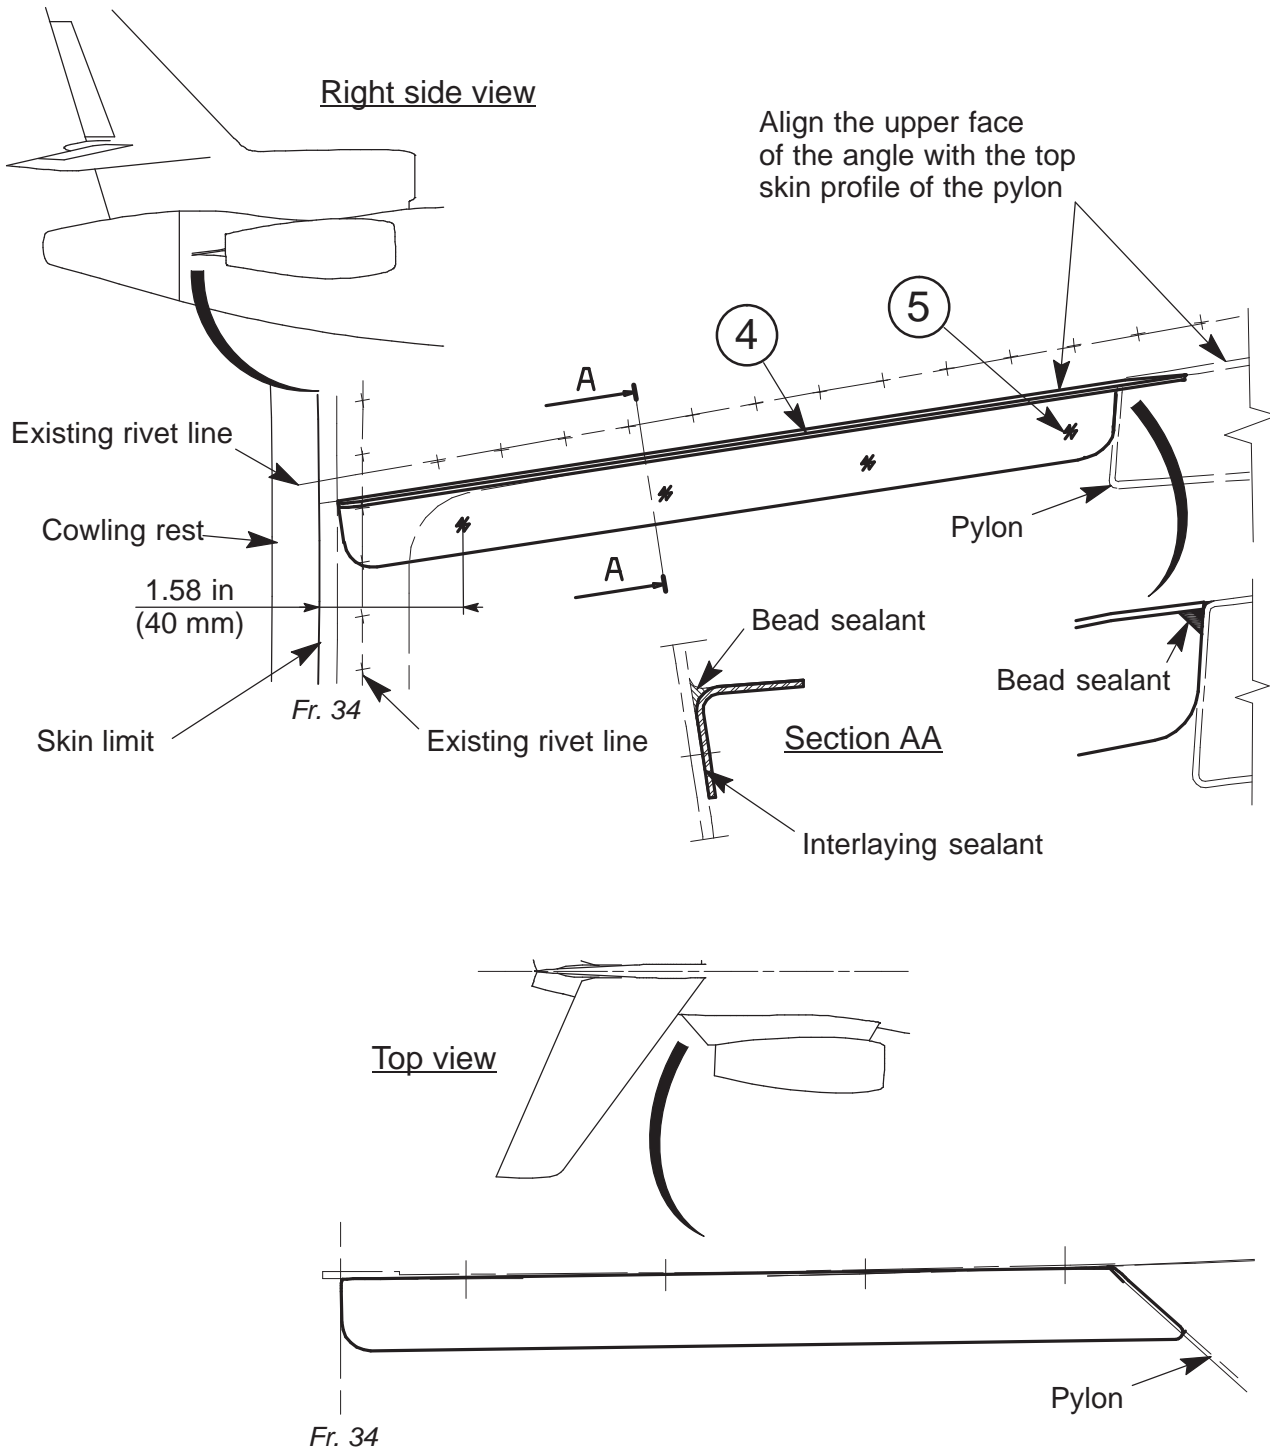
- FIGURE 2 -

Gutter for pylon trailing edge without angle section: A/C S/N 1 through 165

C . INSTALLATION OF THE ANGLE BEHIND THE TRAILING EDGE OF THE RH PYLON FOR AIRCRAFT S/N 1 THROUGH 165 (see figure 2)

- (1) Scribe a line protracting the profile of the pylon trailing edge upper surface on the fuselage.
- (2) Position the angle in accordance with the line and counterdrill the fuselage to dia. 0.1 in (2.5 mm).
- (3) Enlarge the holes in the angle and the fuselage to dia. 0.125 in (3.3 mm).
- (4) Draw the outline of the angle on the fuselage.
- (5) Remove the angle.
- (6) Countersink the holes in the angle for rivets (item 5).
- (7) Rub the setting surface of the angle on the fuselage and clean.
- (8) Install the angle with interlaying sealant, using rivets (item 5).
- (9) Apply the bead of sealant between angle and fuselage, and angle and pylon.
