## SERVICE BULLETIN

**TITLE: ENGINE FUEL AND CONTROL - REPOSITIONING OF FUEL FLOW TRANSMITTERS**

Model 390 Premier I, Serials RB-1, RB-4 through RB-15, RB-17 through RB-58, RB-59 through RB-80, RB-82 and RB-84.

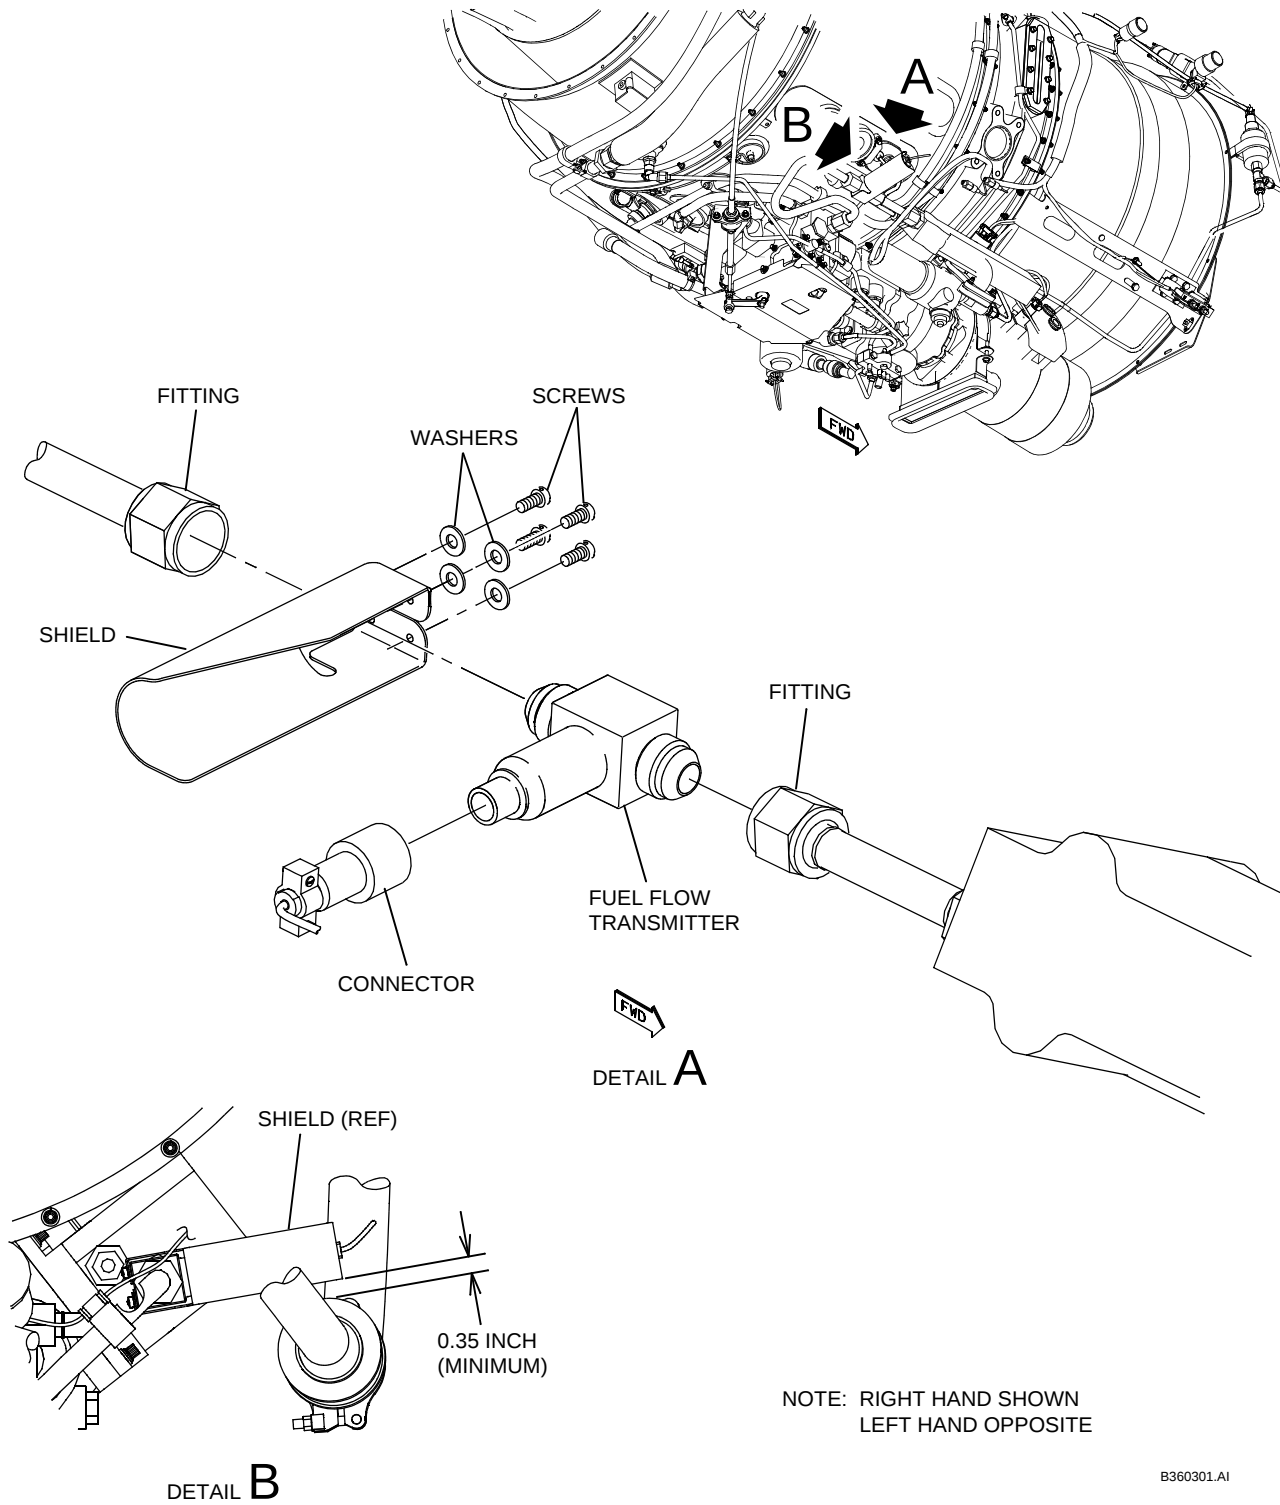
**Repositioning of the Fuel Flow Transmitter and Shield Installation**  
**Figure 1**

This Service Bulletin is being issued because Raytheon Aircraft Company (RAC) has received reports from the field of intermittent fuel flow indications. The fuel flow transmitters P/N 1/2-1-81-302 were inspected and found to have fuel inside the electrical connector. During engine installation at production, air is purged from the fuel system by temporarily loosening the fuel line connections at the fuel flow transmitter. Any fuel that escapes during this procedure migrates down the body of the fuel flow transmitter and collects in the electrical connector.

This Service Bulletin provides information to reposition the fuel flow transmitter to prevent fuel from collecting in the electrical connector. Instructions are also provided to install a heat shield on the fuel flow transmitter to prevent bleed air heat damage to the fuel flow transmitter.

- (3) Install shield P/N 390-910327-0003 to left and right fuel flow transmitter with four screws P/N MS35275-242 and four washers P/N NAS1149DN832J and secure with safety wire. Refer to Figure 1.
- (4) Install left and right fuel flow transmitters (refer to AMM, Chapter 73-30-01) with the exception that the fuel flow transmitter is rotated up 180° so that the electrical connector is above the bleed air tube. Make sure that there is a minimum gap of 0.35 inch between the fuel flow transmitter shield and the bleed air tube. Refer to Figure 1.
- (5) Reconnect the airplane battery, remove warning notices and restore power.
- (6) Ensure all work areas are clean and clear of tools and miscellaneous items of equipment.
- (7) Return airplane to service.
