FBC Justin sprinkler system layout

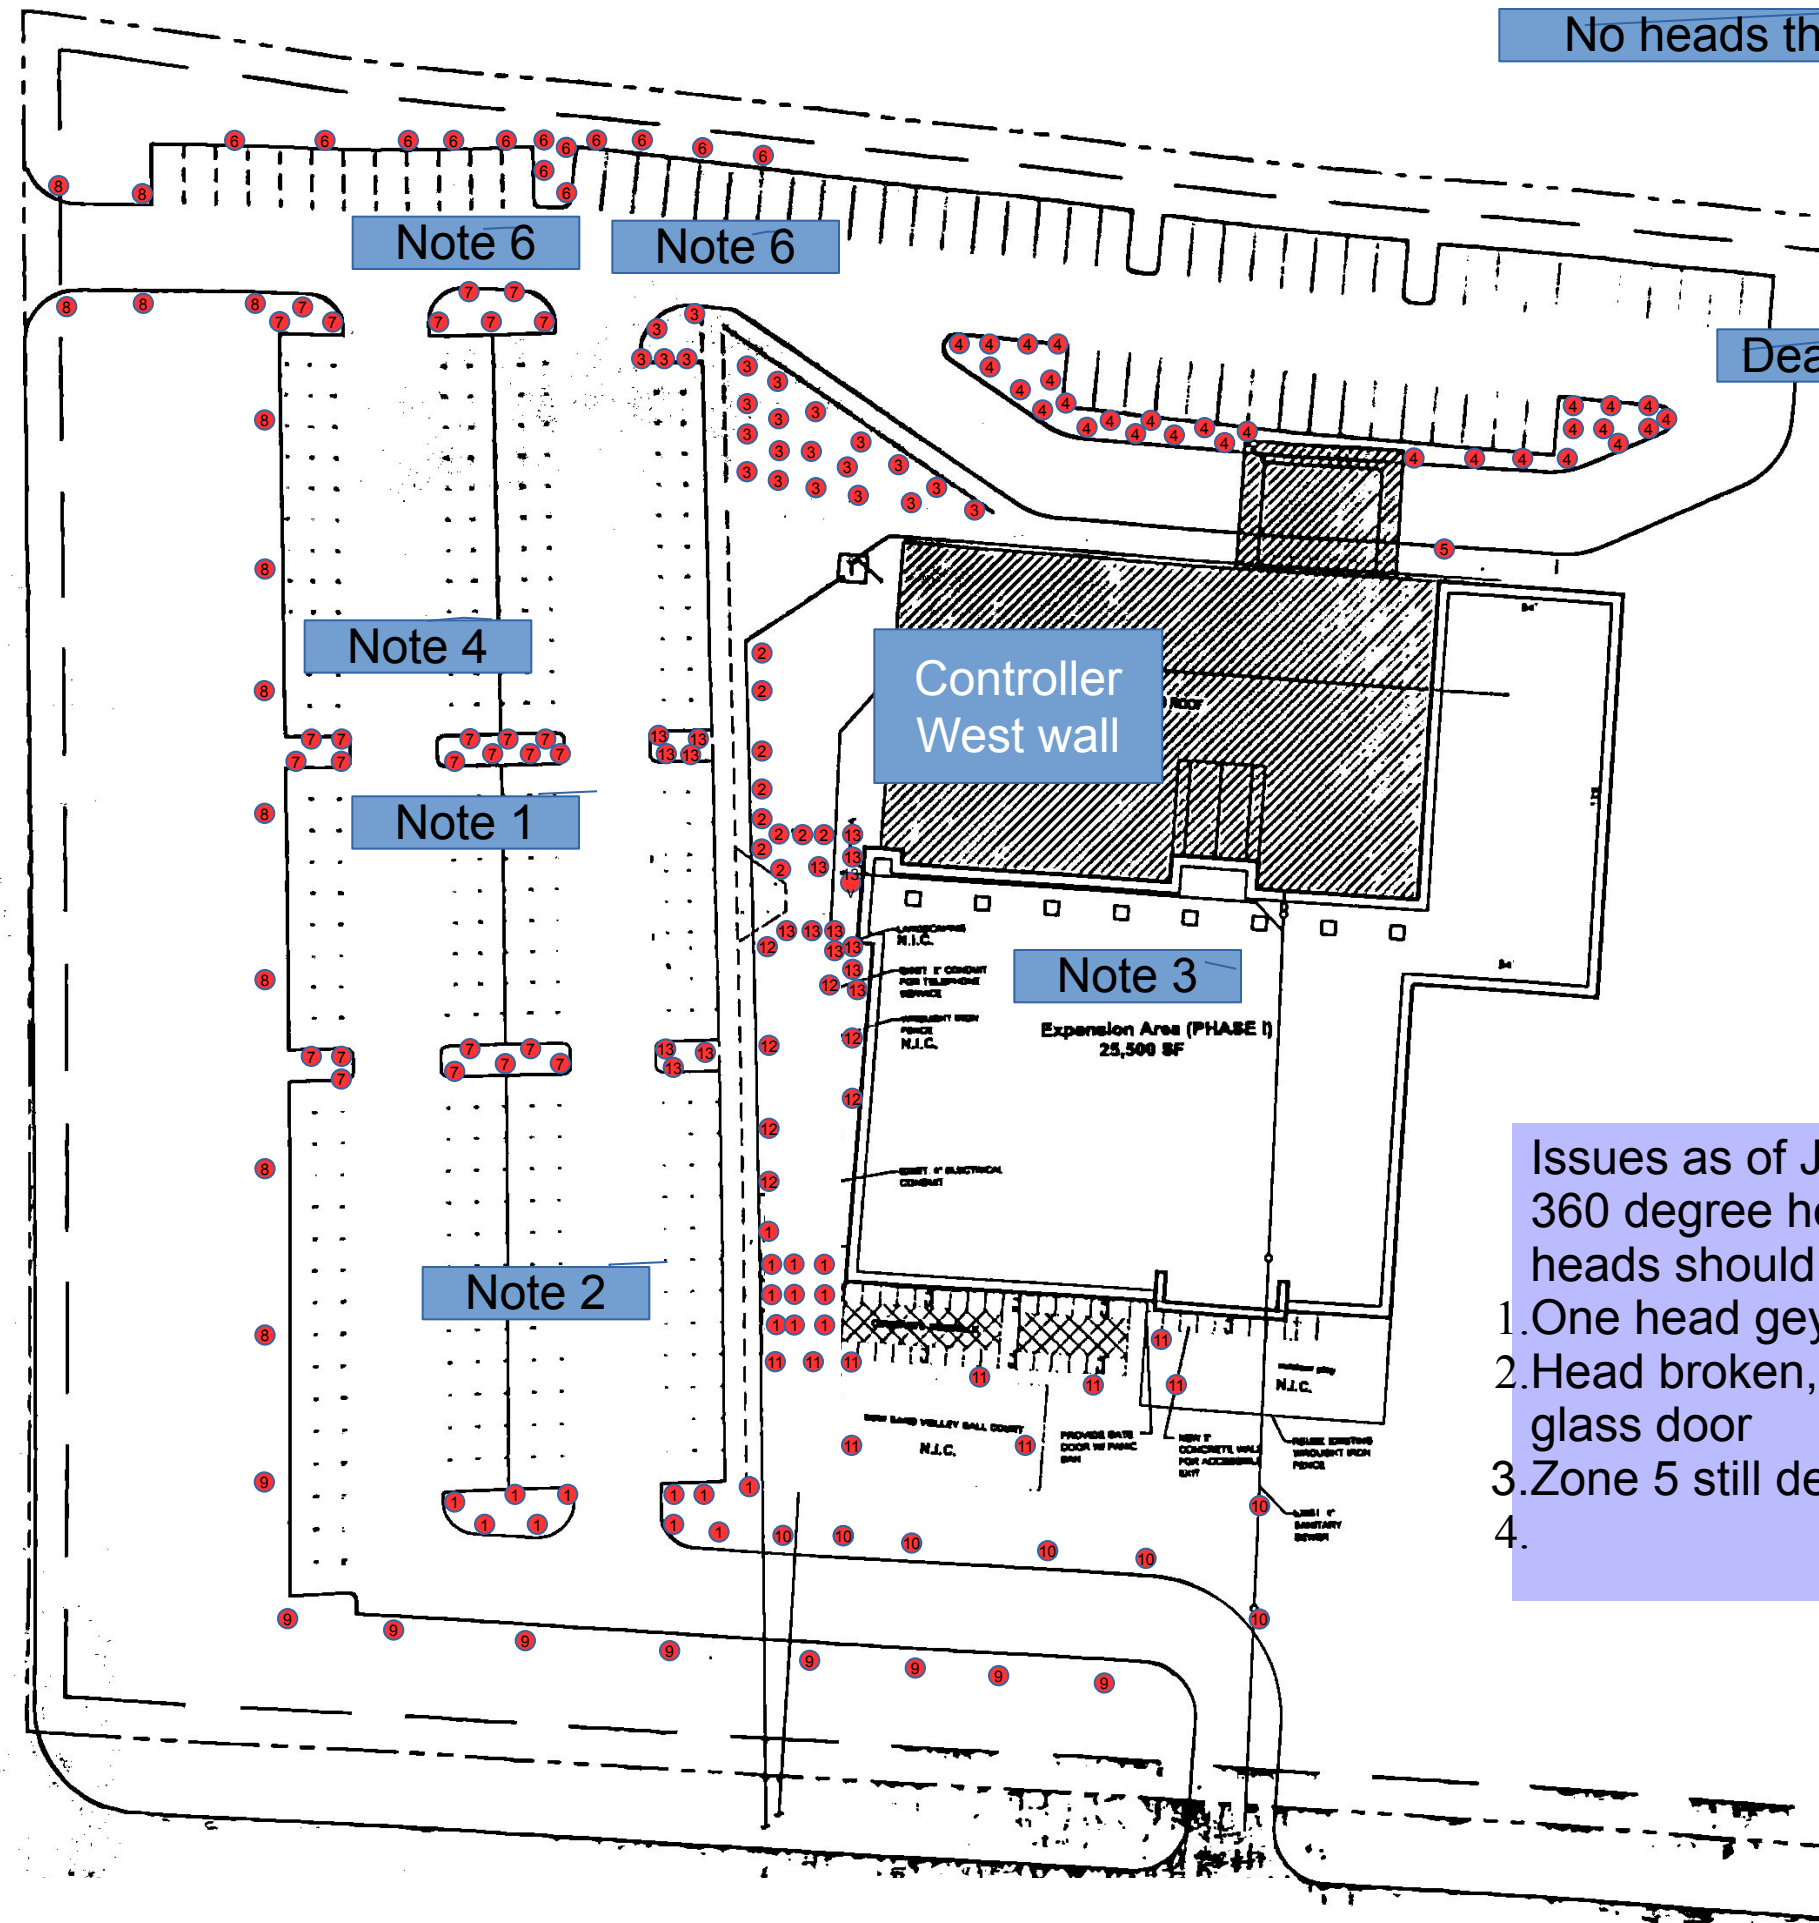
No heads this area?

Dead note 7

- Issues as of June 2023
360 degree heads where 180 degree heads should be installed
1. One head geyser, zone 13, near tree
 2. Head broken, zone 13 near west glass door
 3. Zone 5 still dead
 - 4.
