FLAP RAC CONTROL

SLAT RAC CONTROL

POWER AND GROUND ANALYSIS

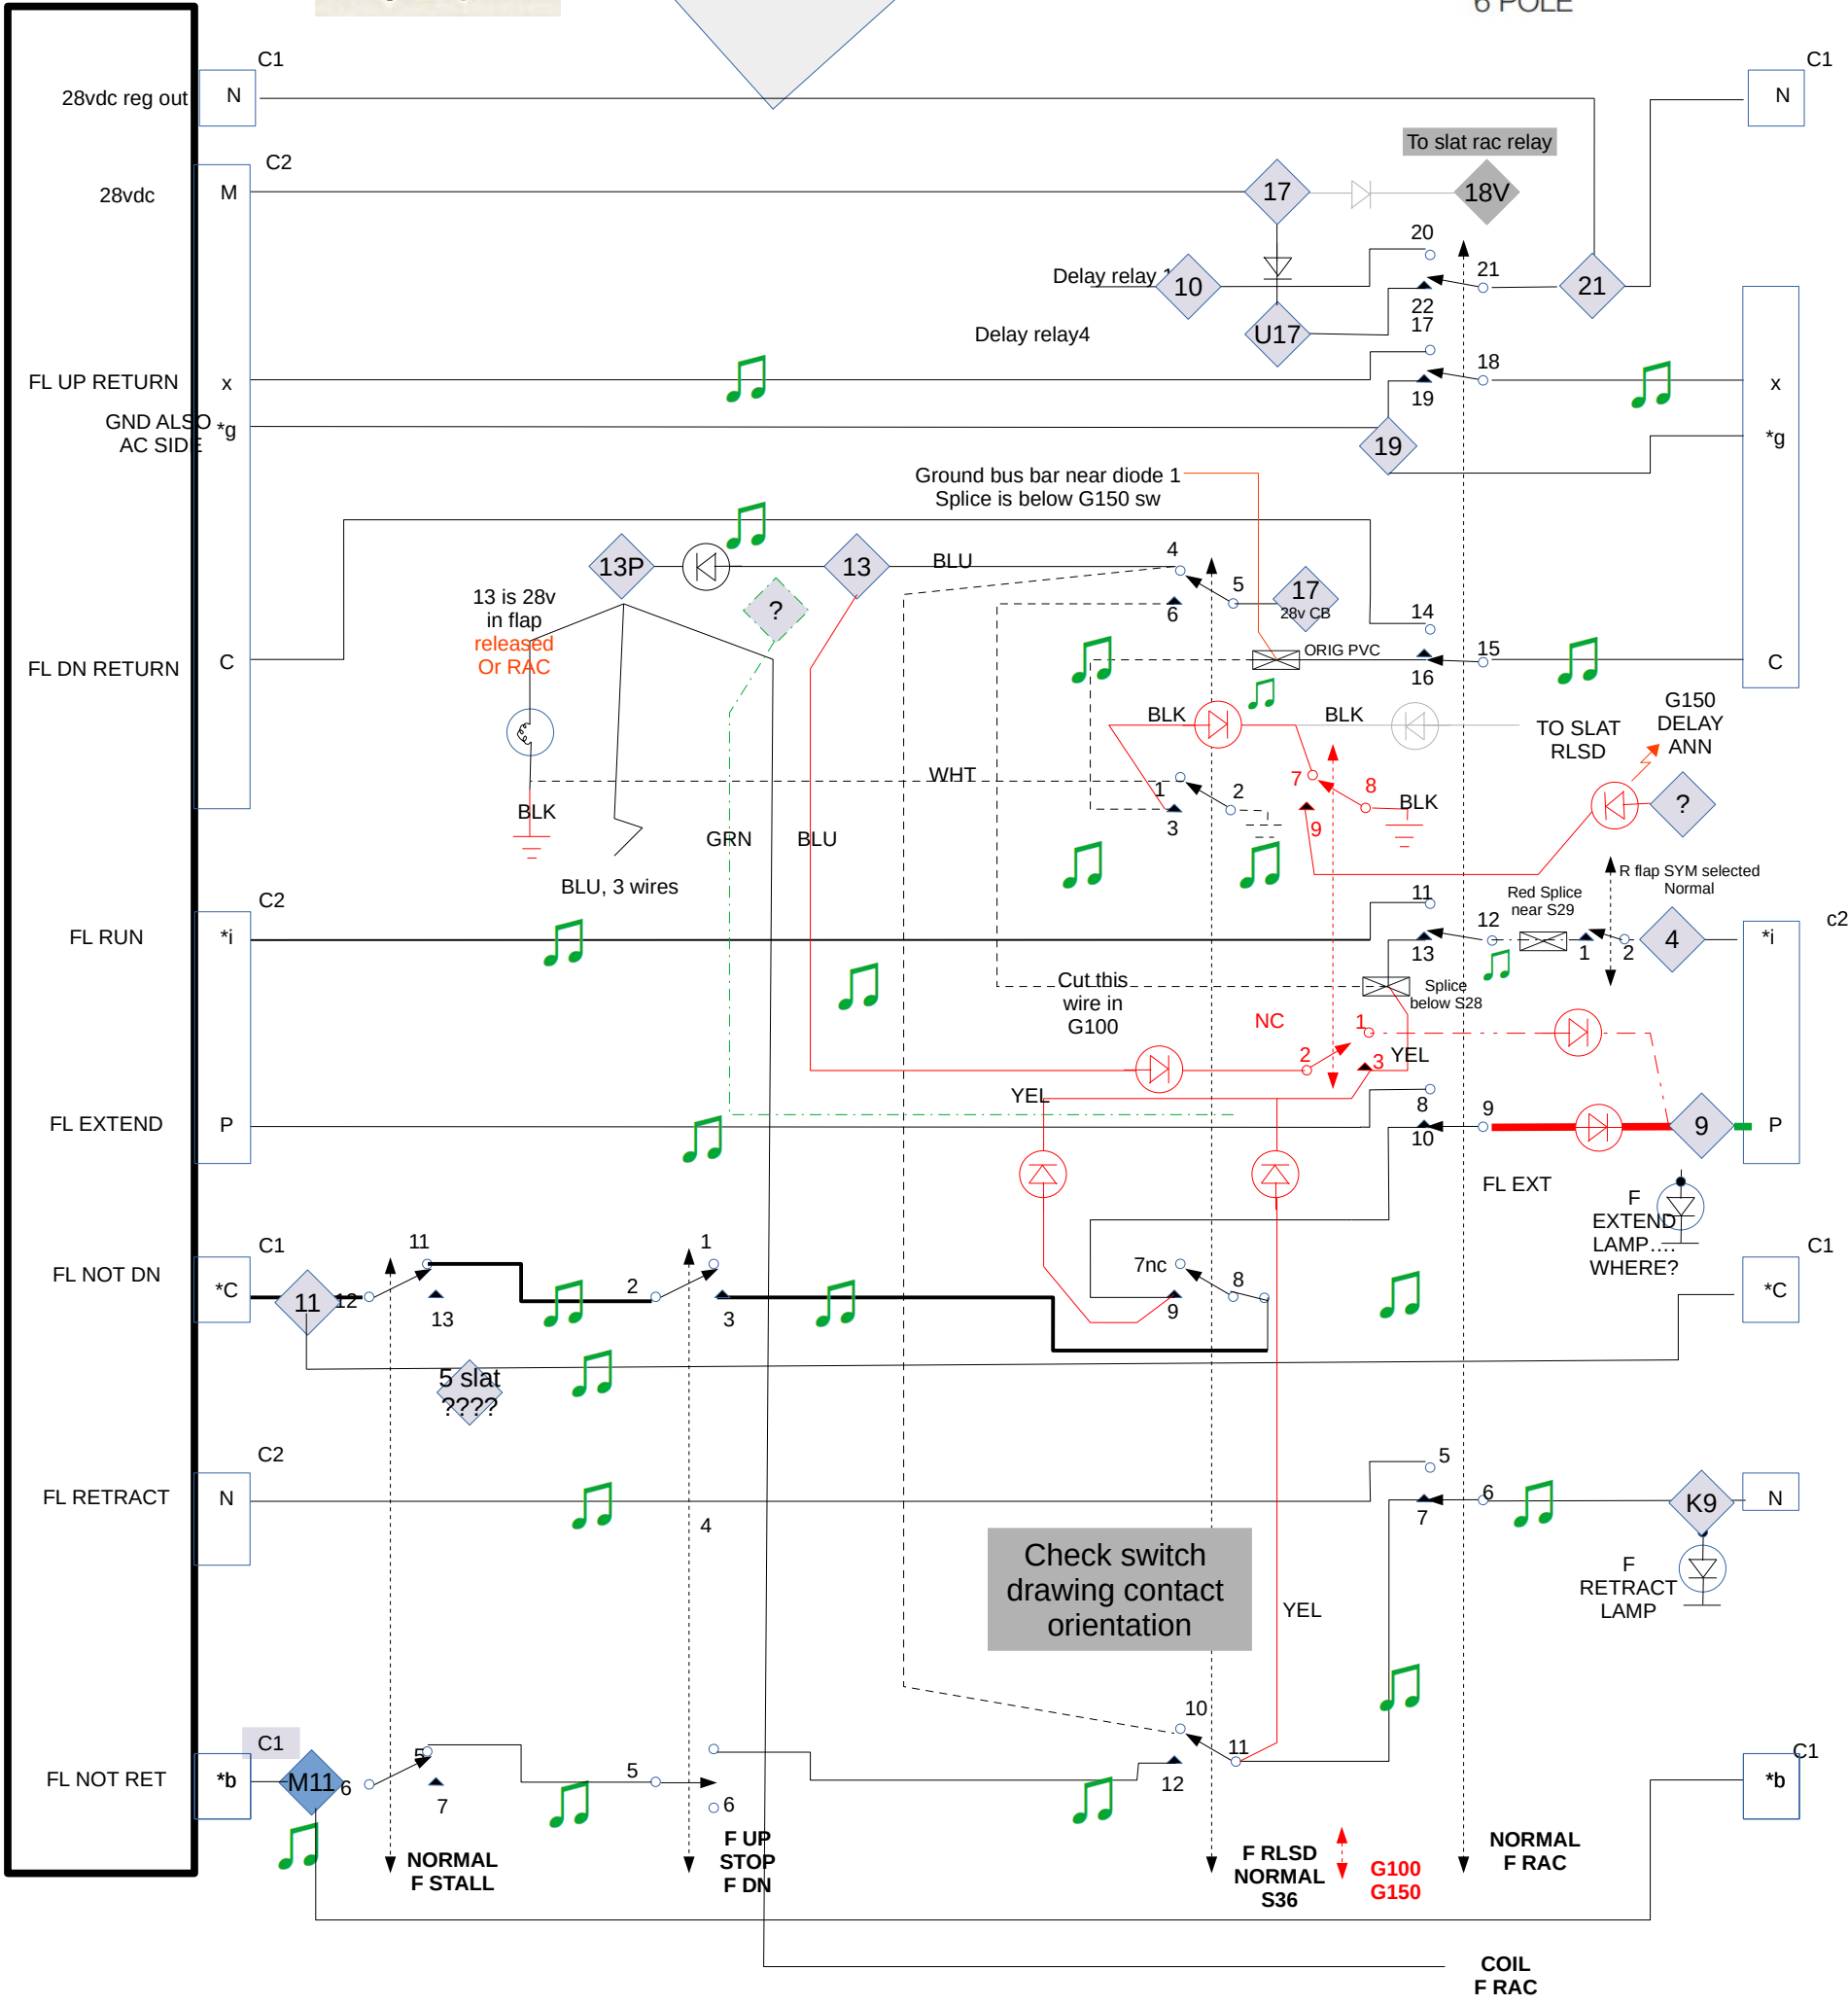
Red lines  
are added  
wires for  
G150  
delay

Dashed  
lines are  
original  
wires to  
be  
removed

Modify unit for Gulfstream G150 / BRAKE DELAY feature. This will add a single switch, with placarding.  
Added new wires and switch. Added placard for test fit.

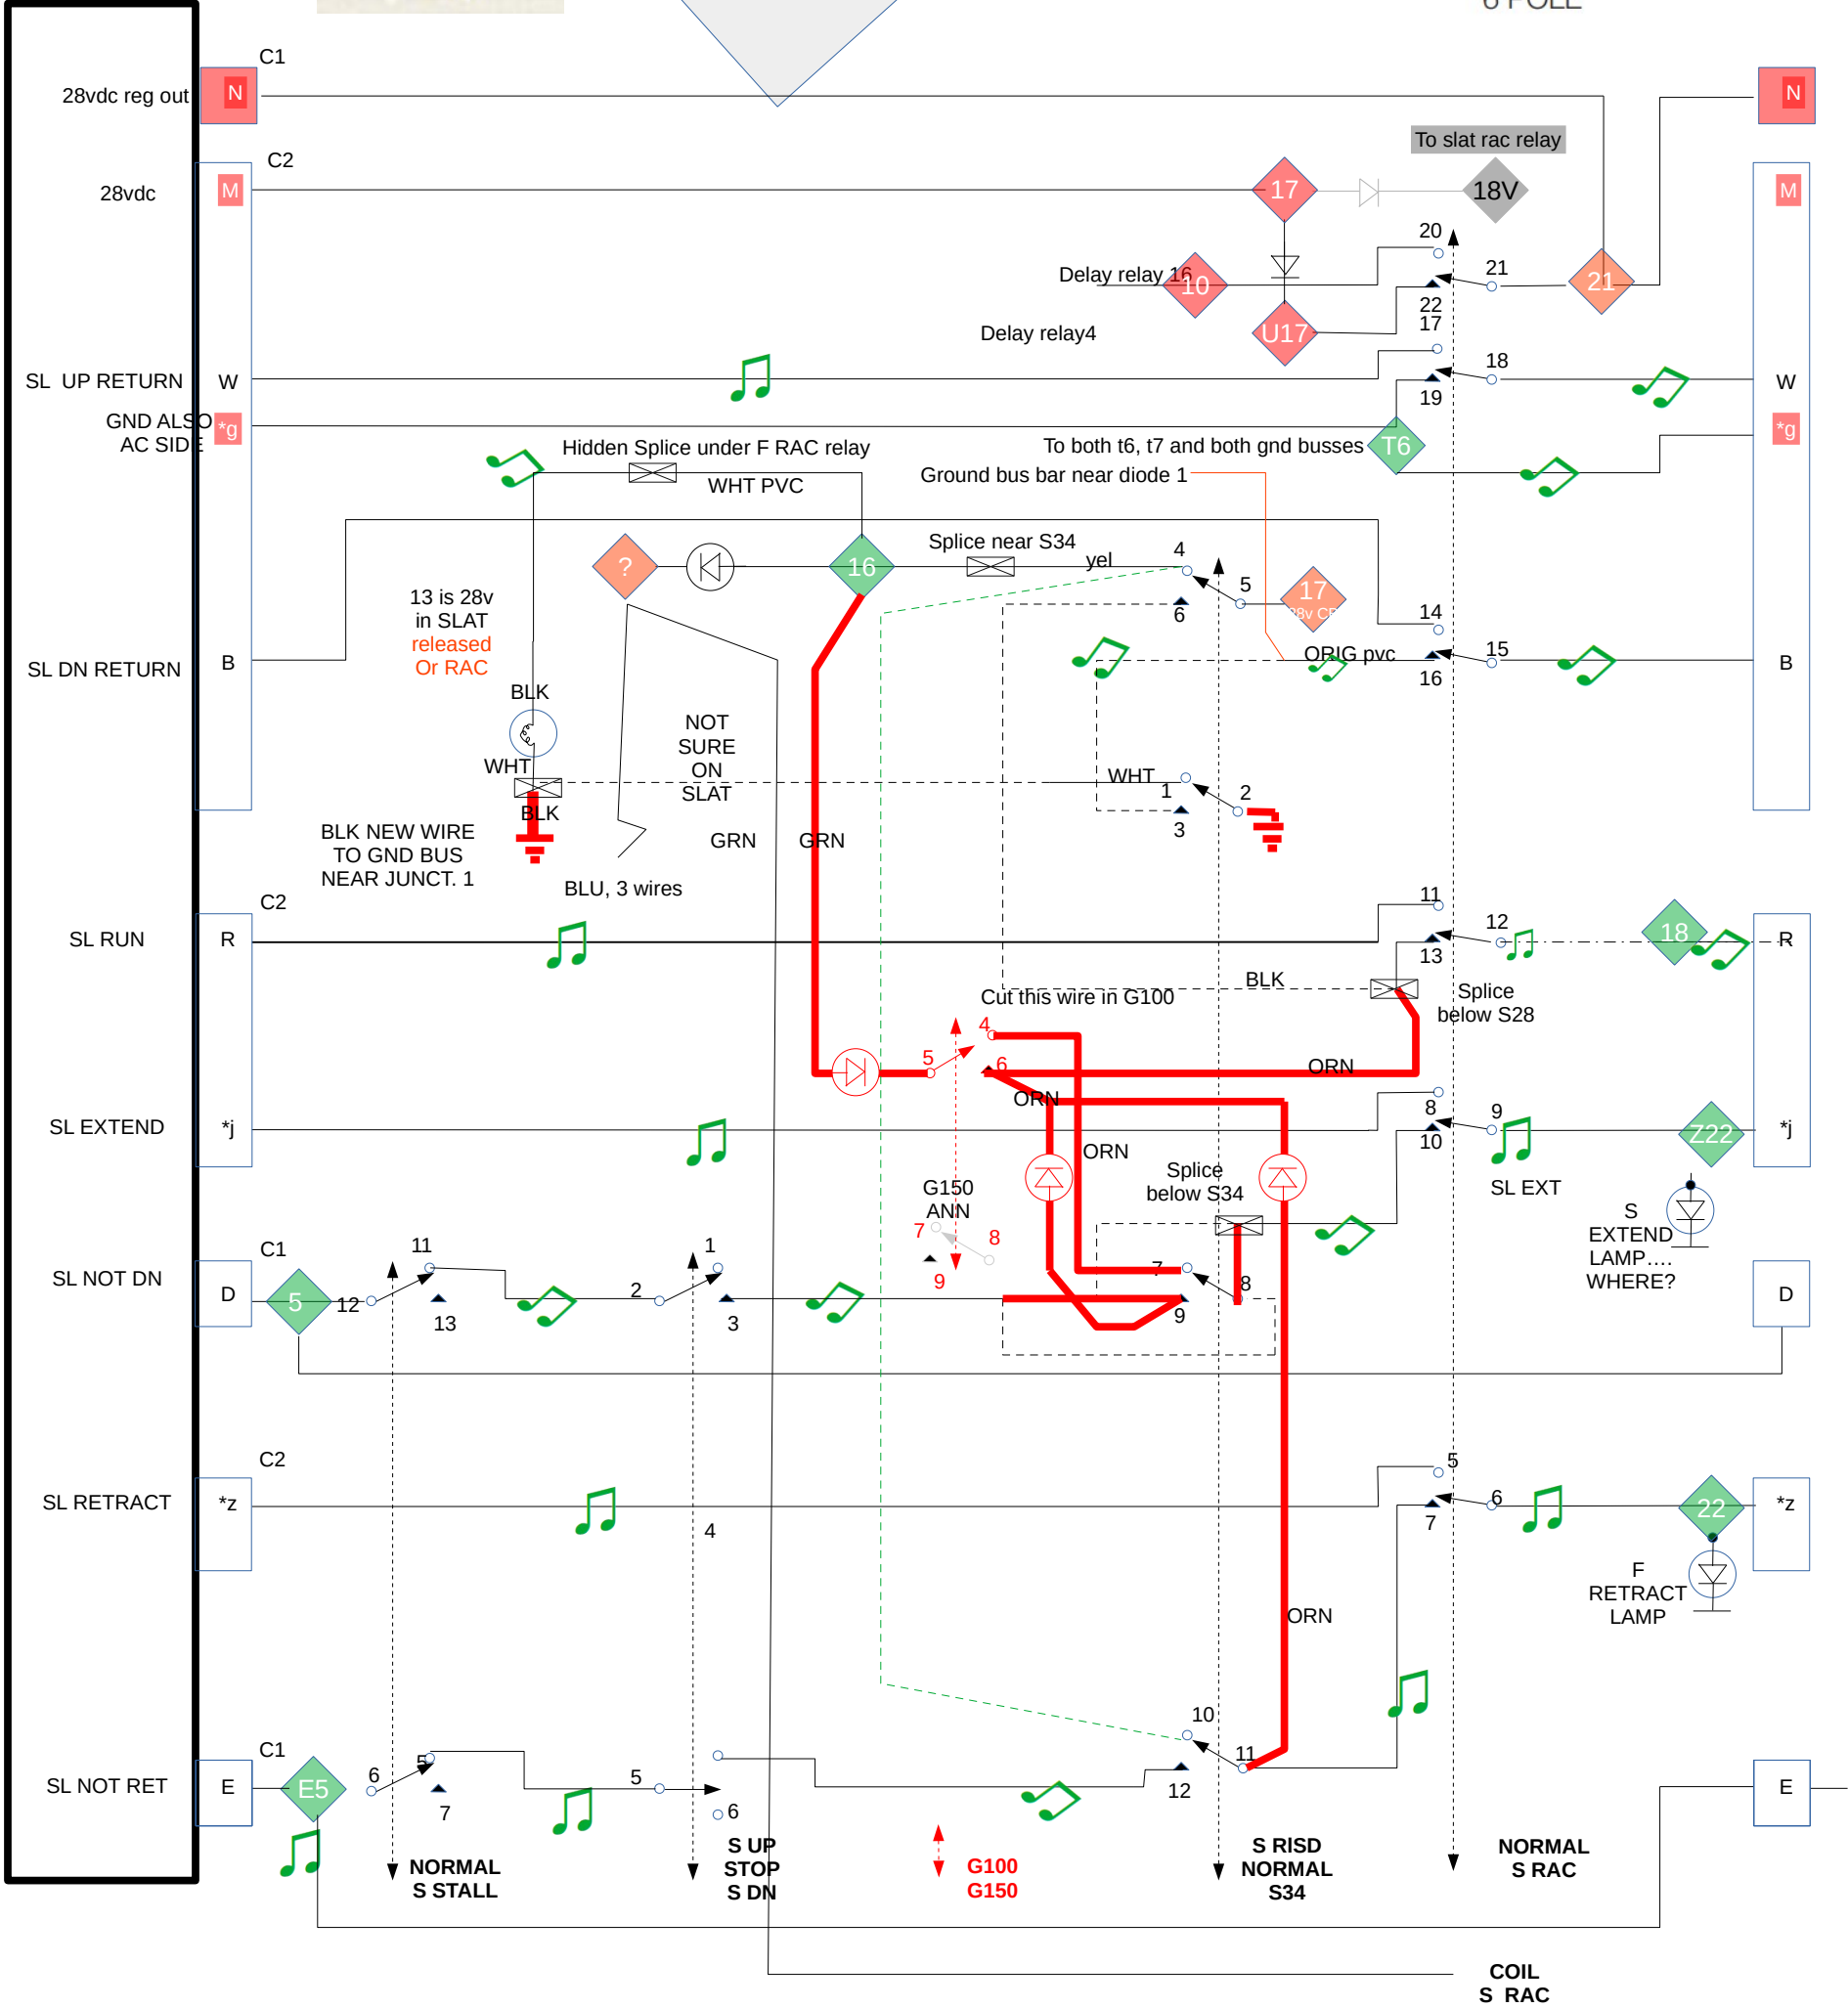
SLAT DOWN RETURN IS NOT  
ACTIVE IN S RLSD WHEN MOD  
BEGAN

STRAIGHT NOTE  
IS COPY /PASTE  
FROM FLAP  
CIRCUIT

SLANTED NOTE IS  
RUNG OUT ON  
SLAT CIRCUIT

Red lines  
are added  
wires for  
G150  
delay

Dashed  
lines are  
original  
wires to  
be  
removed

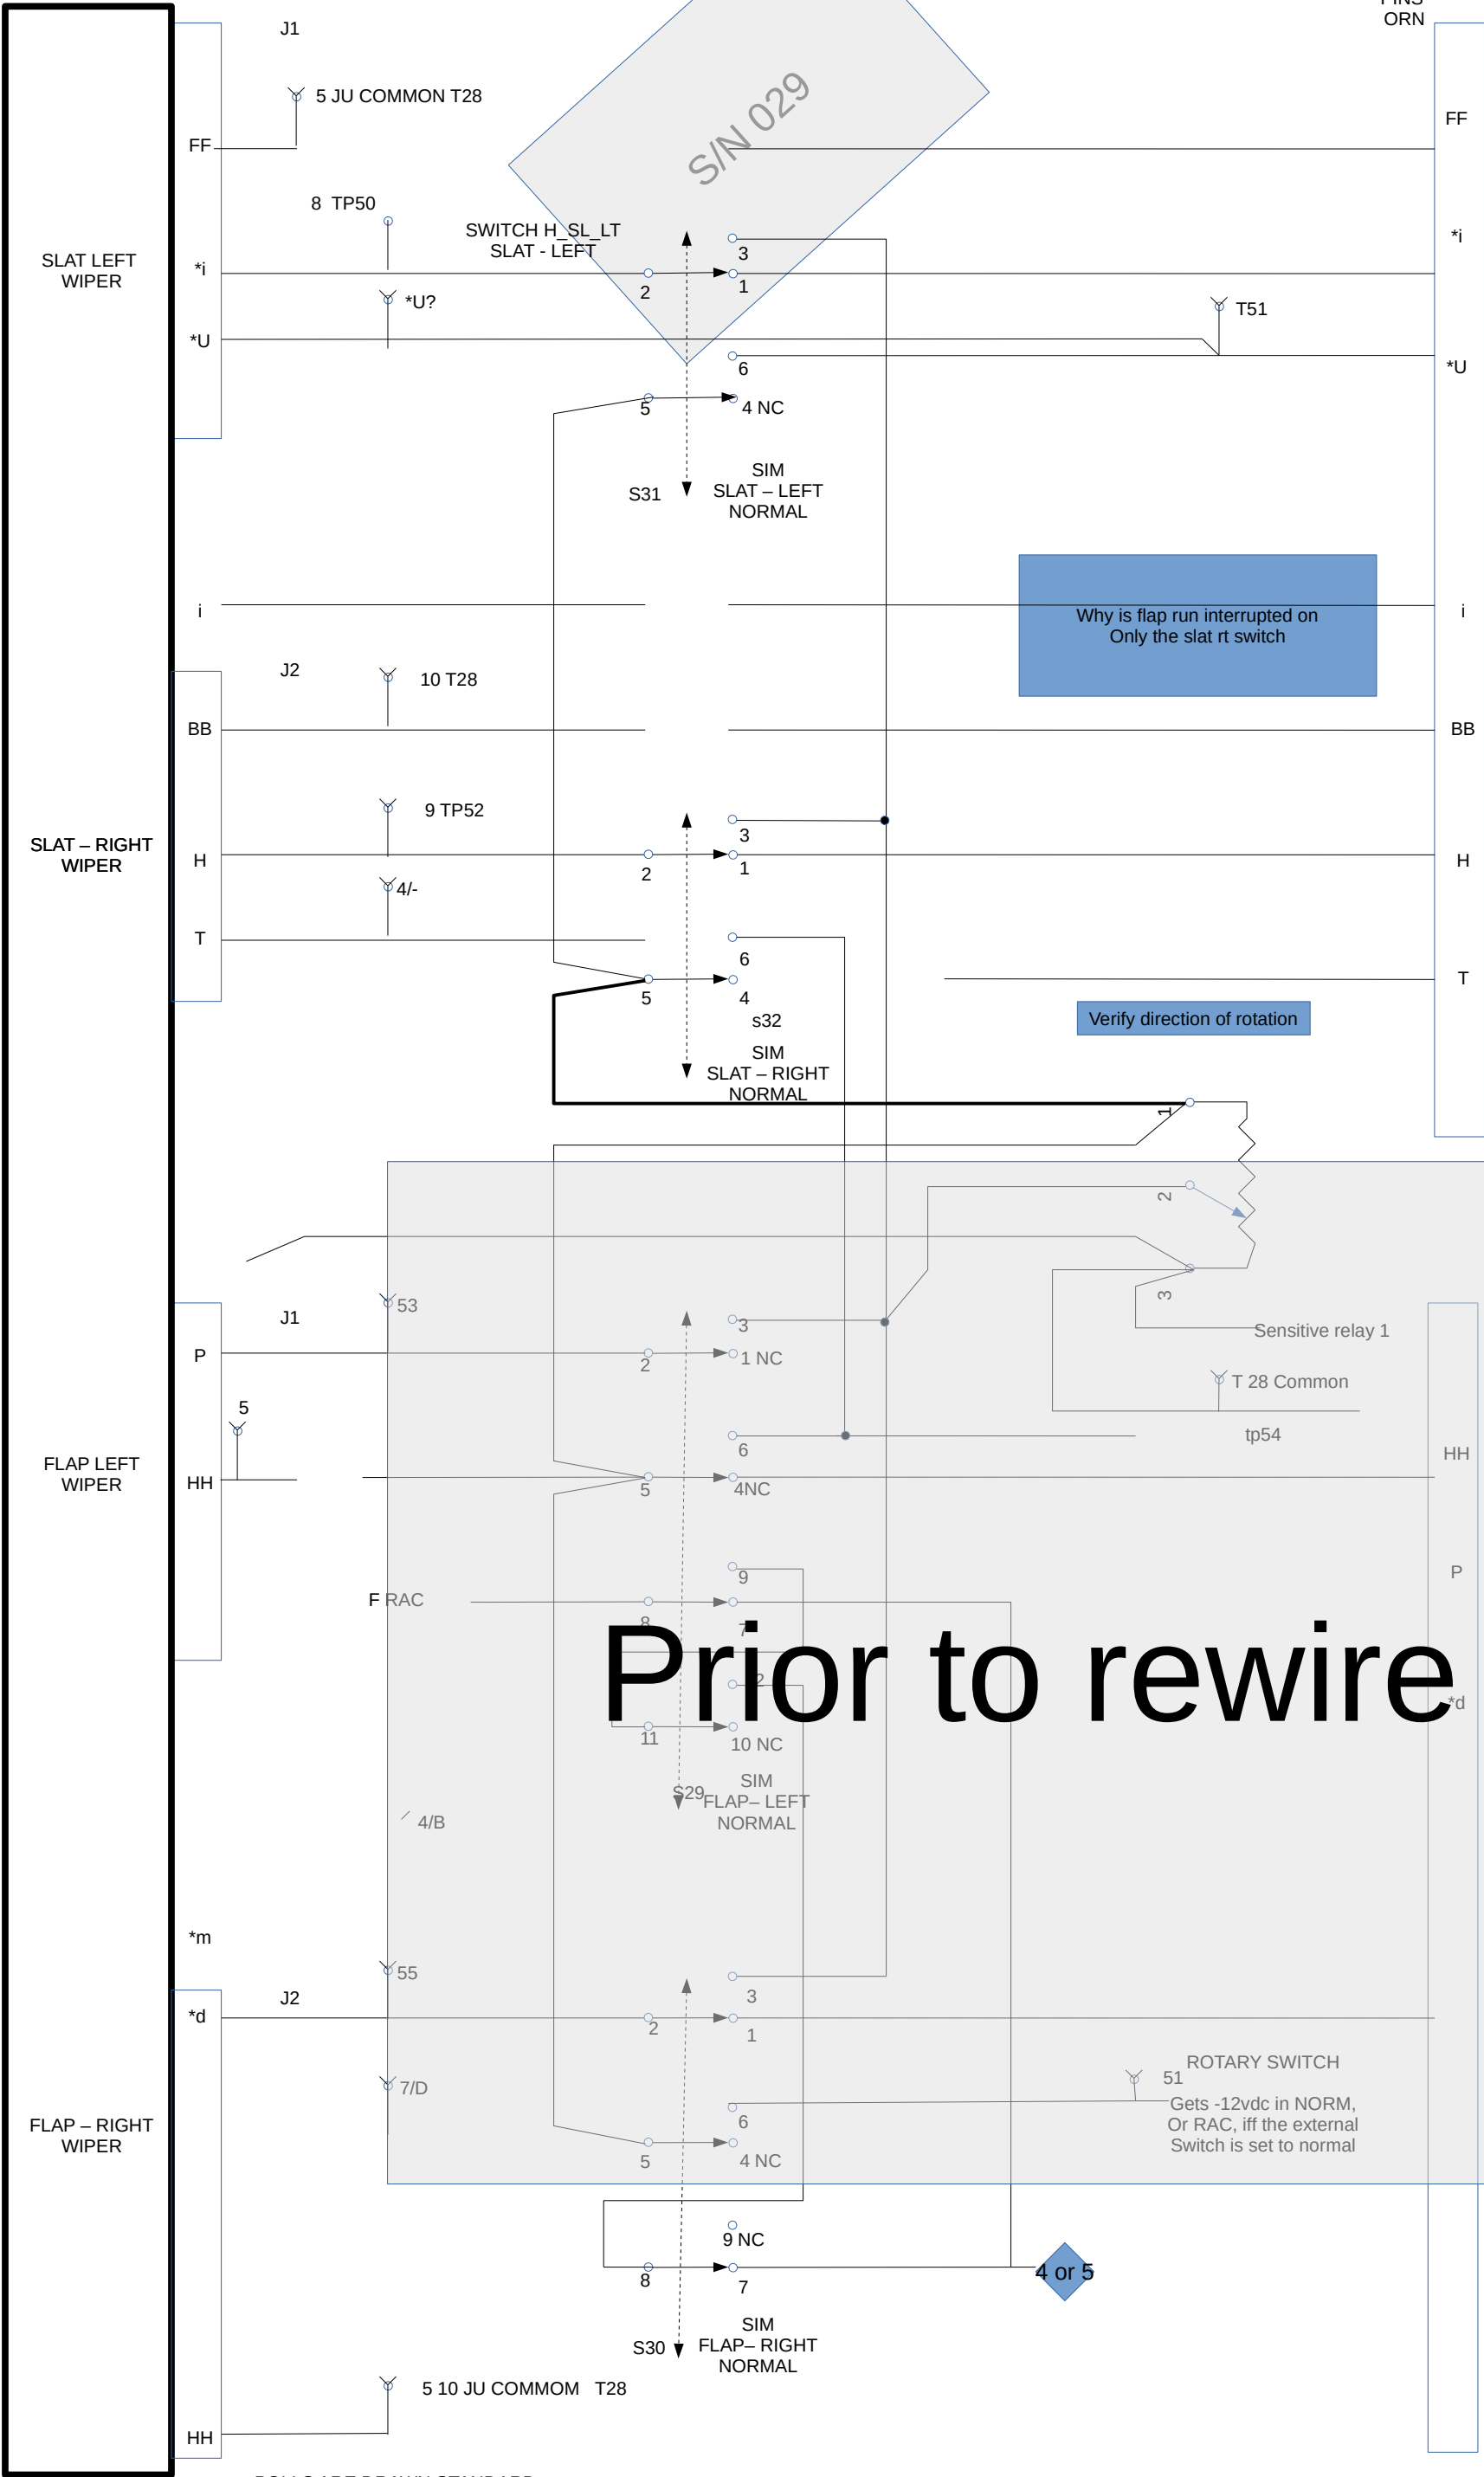
SLAT – RIGHT WIPER

B -12VDC

FLAP – RIGHT WIPER

A -12VDC

FSECU J92C1 KEYED AT A PINS

FLAP LEFT WIPER

SLAT LEFT WIPER

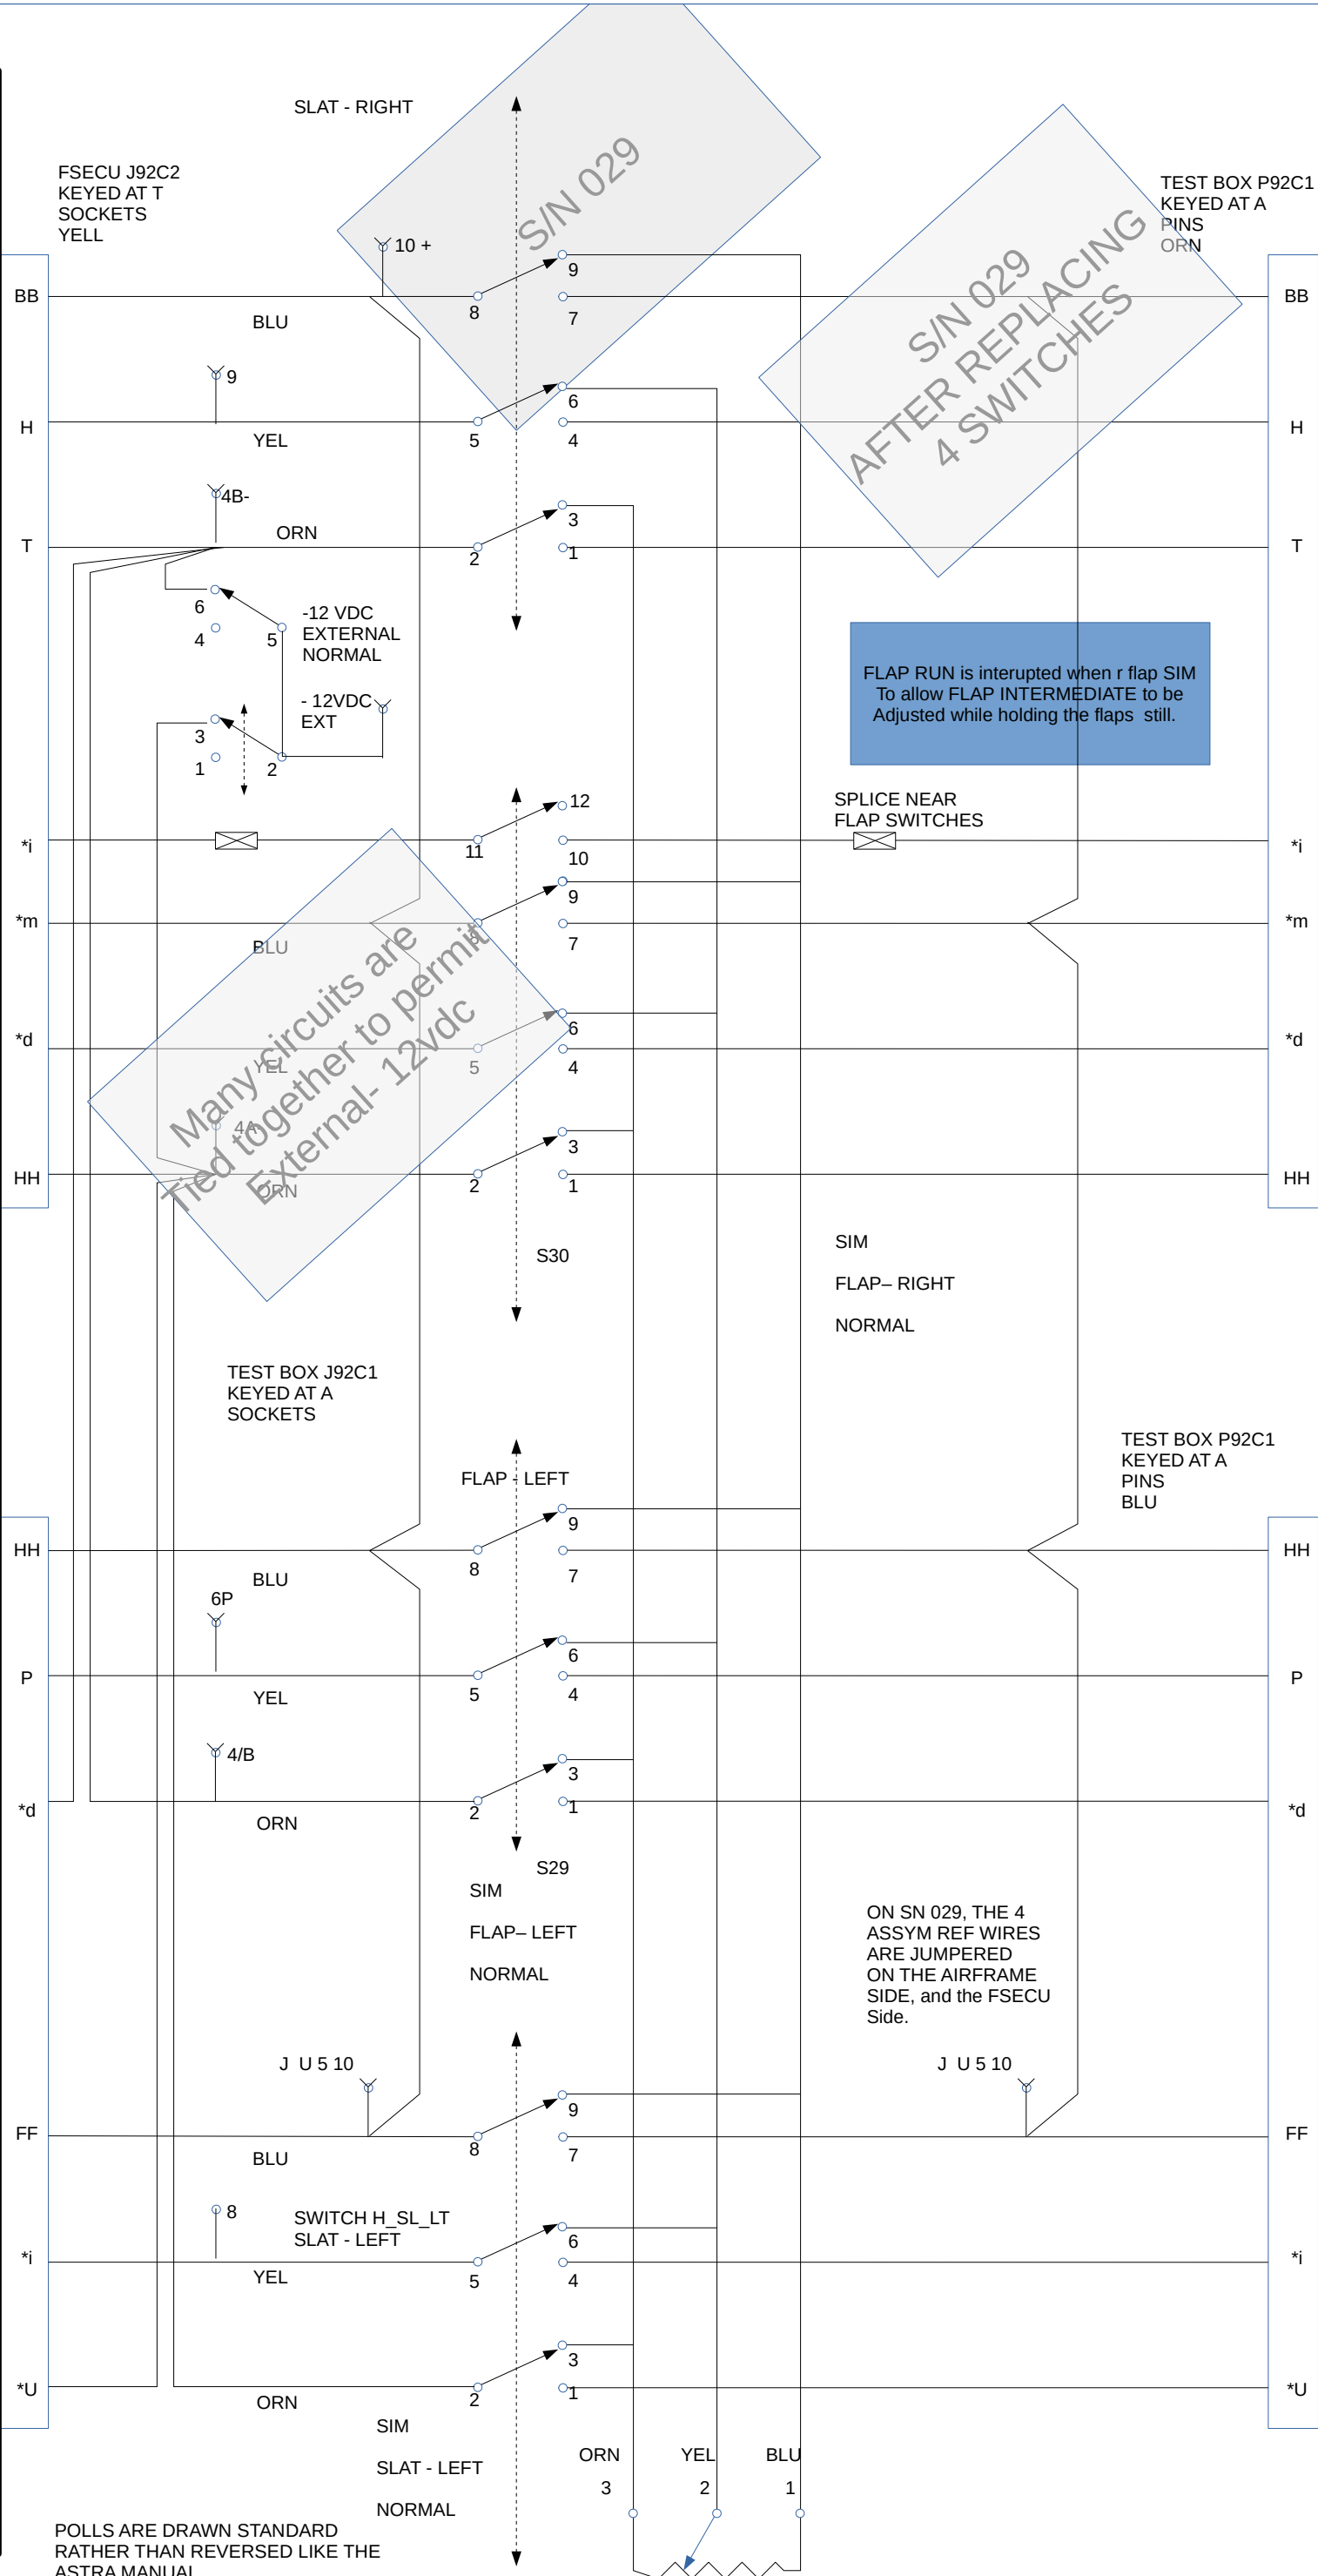
POLLS ARE DRAWN STANDARD RATHER THAN REVERSED LIKE THE ASTRA MANUAL.

Also, FSECU is drawn on the left here , it is on the right in the original

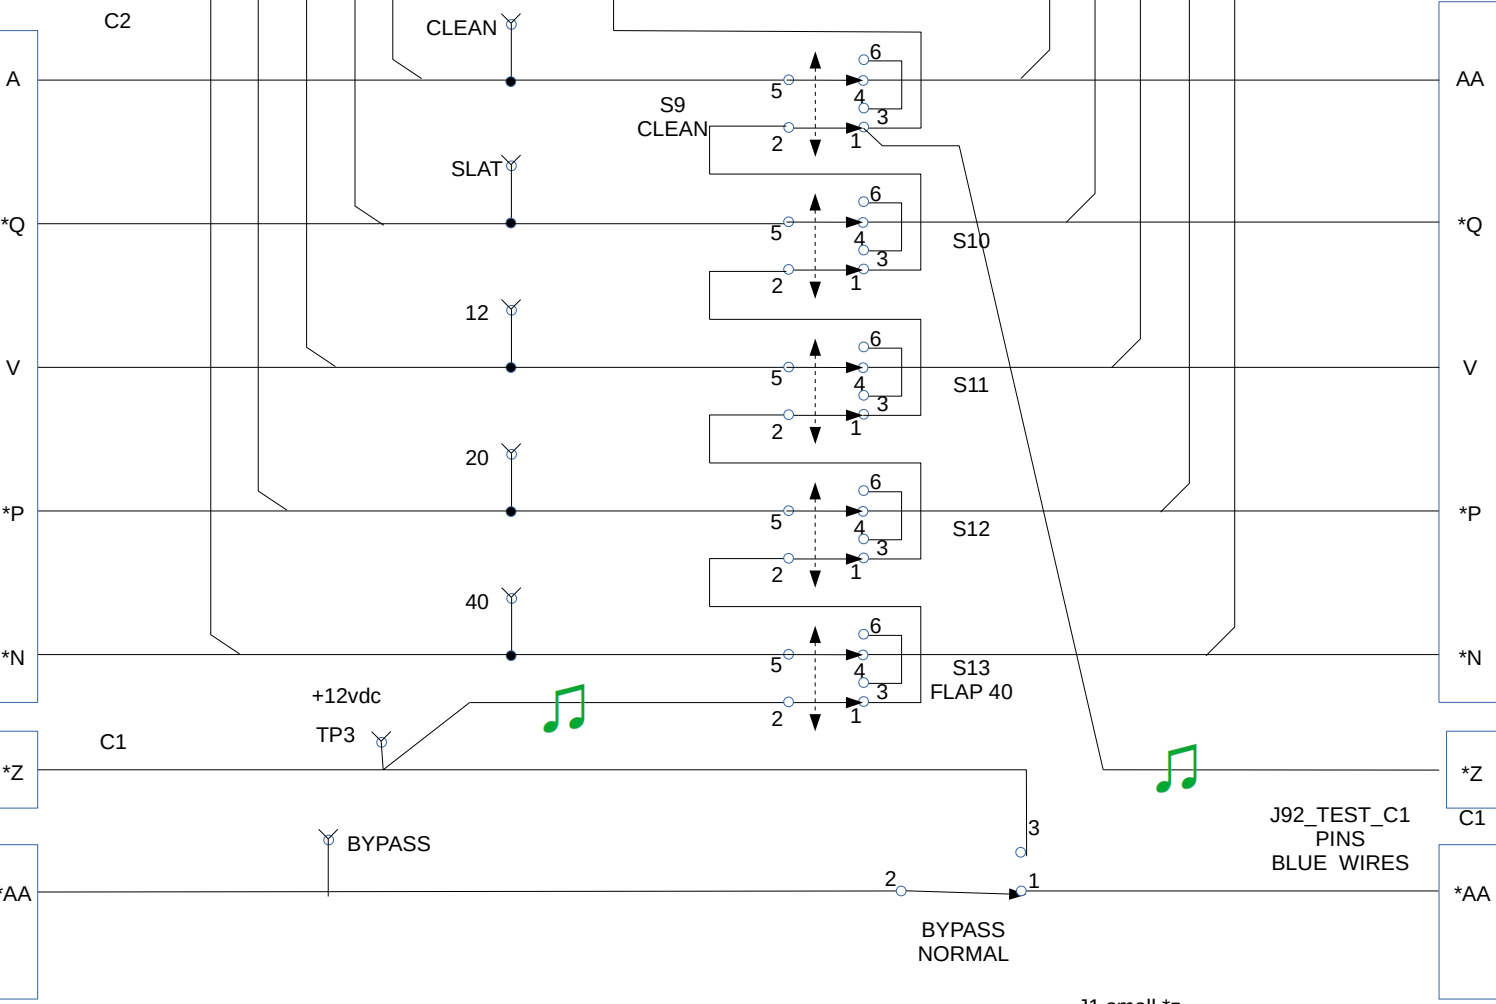
COCKPIT SL UP

COCKPIT SL DN

COCKPIT FL 12

COCKPIT FL 20

COCKPIT FL 40

C1

BYPASS

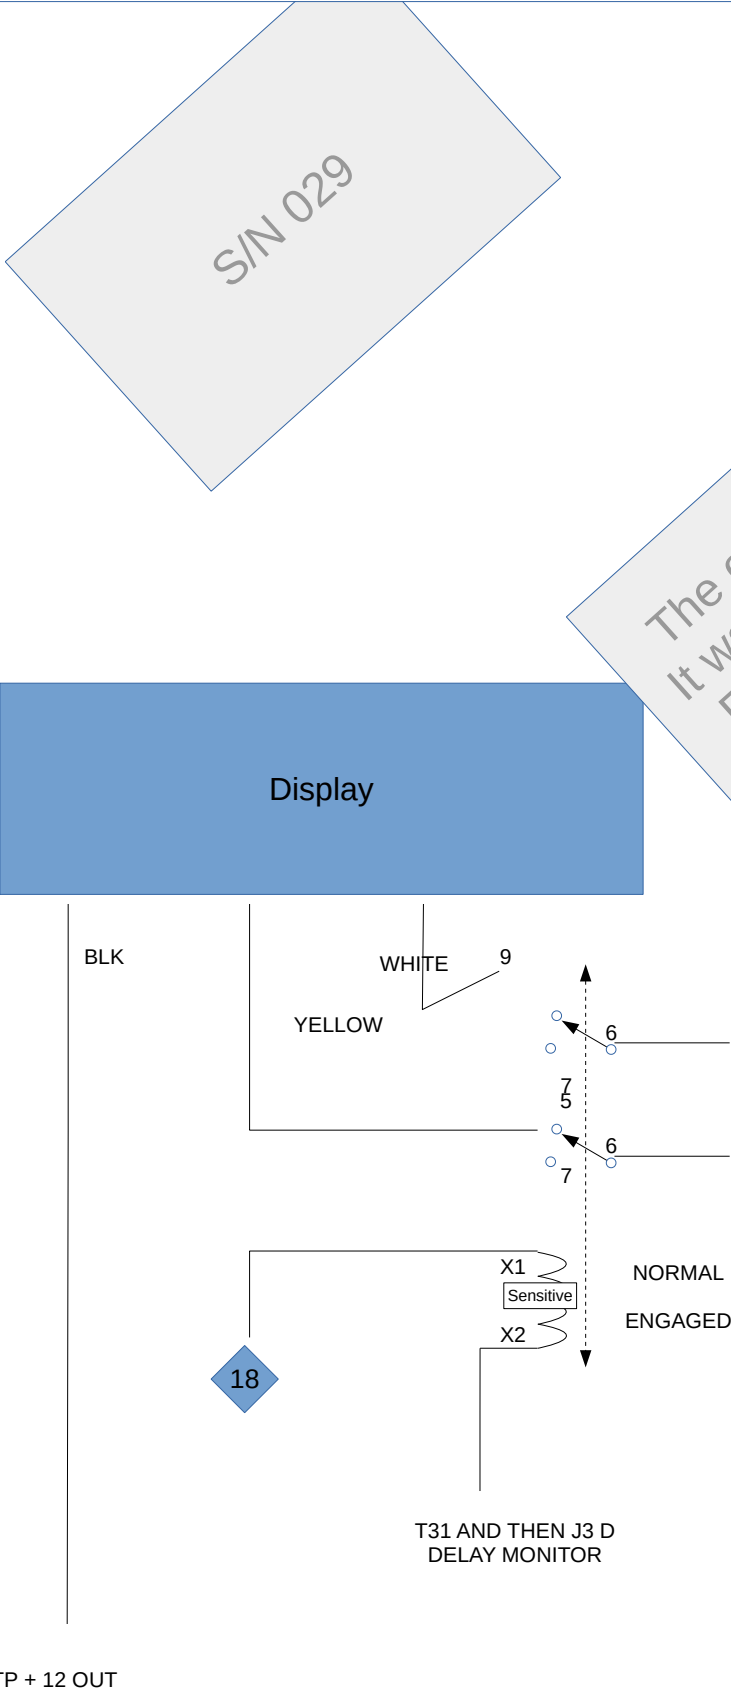
The old display is deprecated.  
It watched C3- pin D for FSECU  
FAULT TIMING. 1.25 seconds

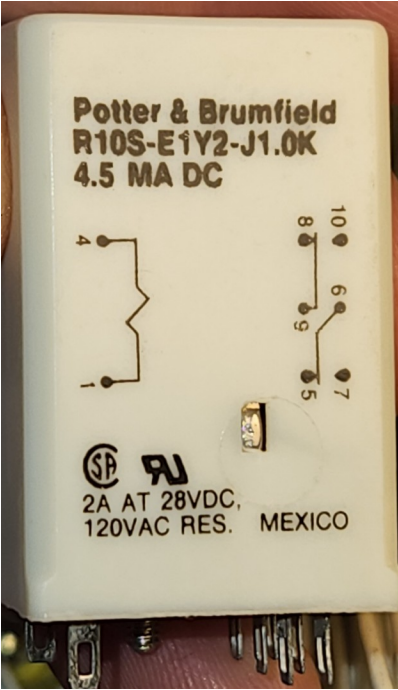
S/N 029

| 22 J2AC *z SL NOT UP |
| 19 sensitive relay 5 |
| 18 SL RUN |
| 17 ship side J2 M, 28 VDC from CB |
| 16 28 v in slat rlstd, added green slat 28v |
| 15 28v in slat rac from rotary sw |
| 14 28v in slat rack??????? |
| 13 28v in FLAP RLSD to power ann, S33-10- now blue wire also I33 |
| 11 J1AC *c FL NOT FULL DN |
| 10 flap dely 4 |
| 9 J2AC - P FLAP DN CMD, FRAC relay 21 |
| 8 SLAT CURRENT to test point |
| 5 SL NOT FULLY EXT - J1AC – D ALSO J1 FSECU |
| 4 BRK 28V, *i rang to acft wire broken, or s55-1 rh flap asym sw, ALSO SLAT STAL RELAY 12, |
| 3 slat delay relay pin 4, x2 |
| 2 FLAP CURRENT |

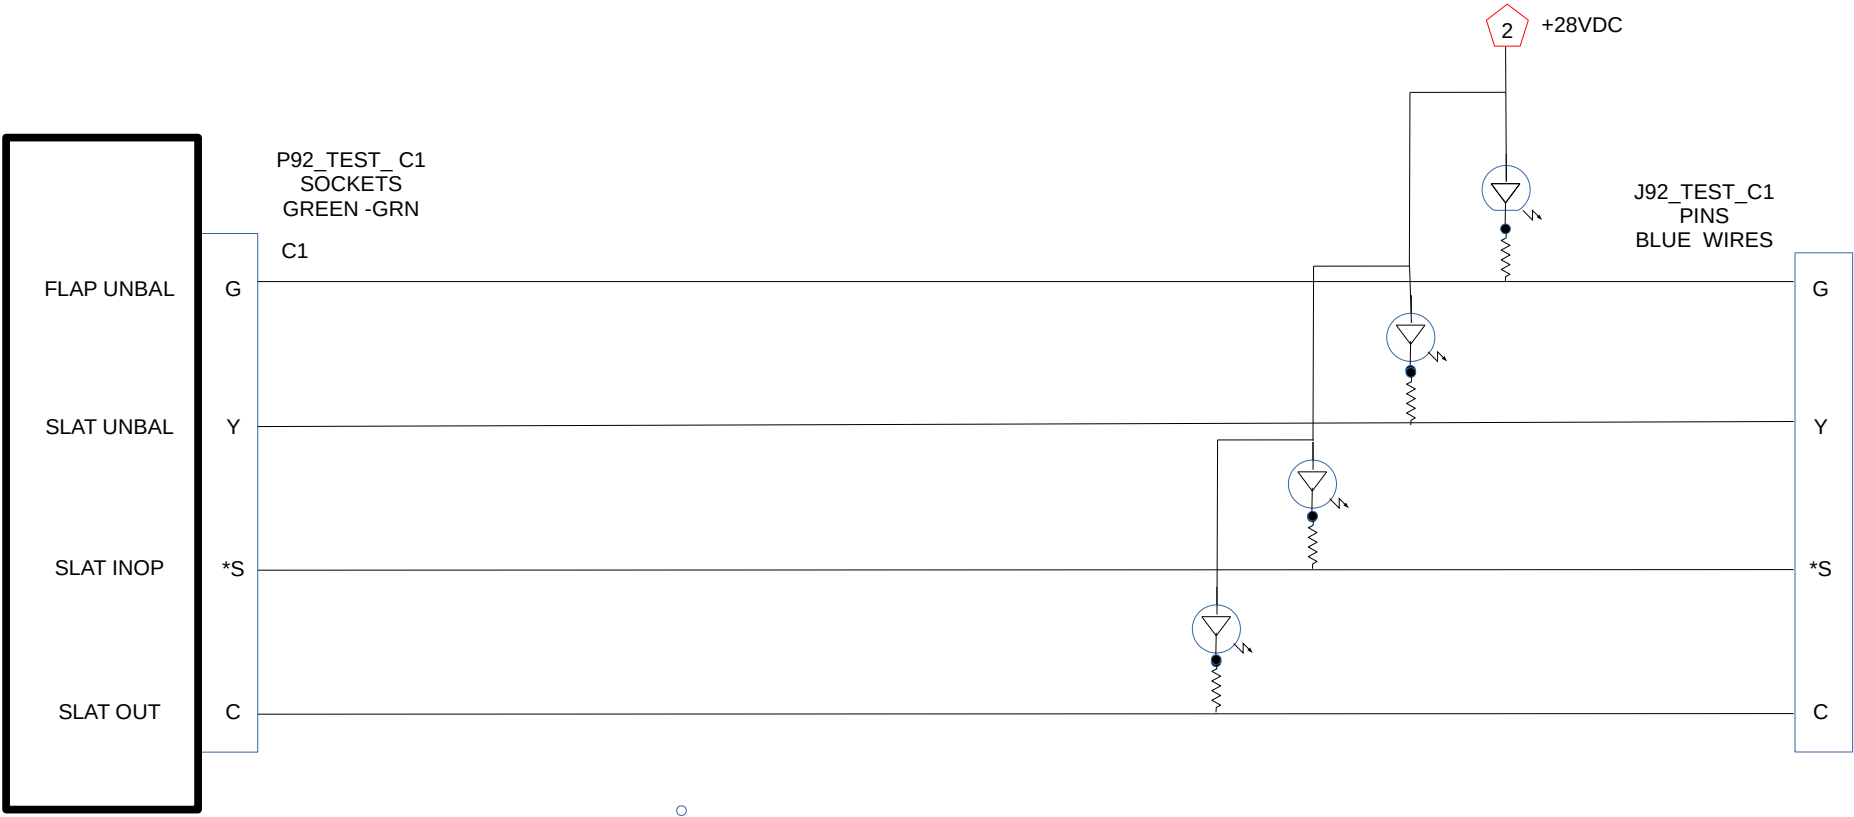
CONNECTIONS TO PCB

FROM PAGE 2 28VDC, GND REF -12VDC,

FROM PAGE 3: RAC CIRCUITS, ASSYM LOCKOUT

FROM PAGE 5: ASSYM LOCKOUT

FROM PAGE 6: NA

FROM PAGE 7: PDU O HEAT, PPDU O'CURRENT

FROM PAGE 8: PDU RESSITOR SIM CIRCUITS

FROM PAGE 9: DIOES INTRERNAL TO THE PCB

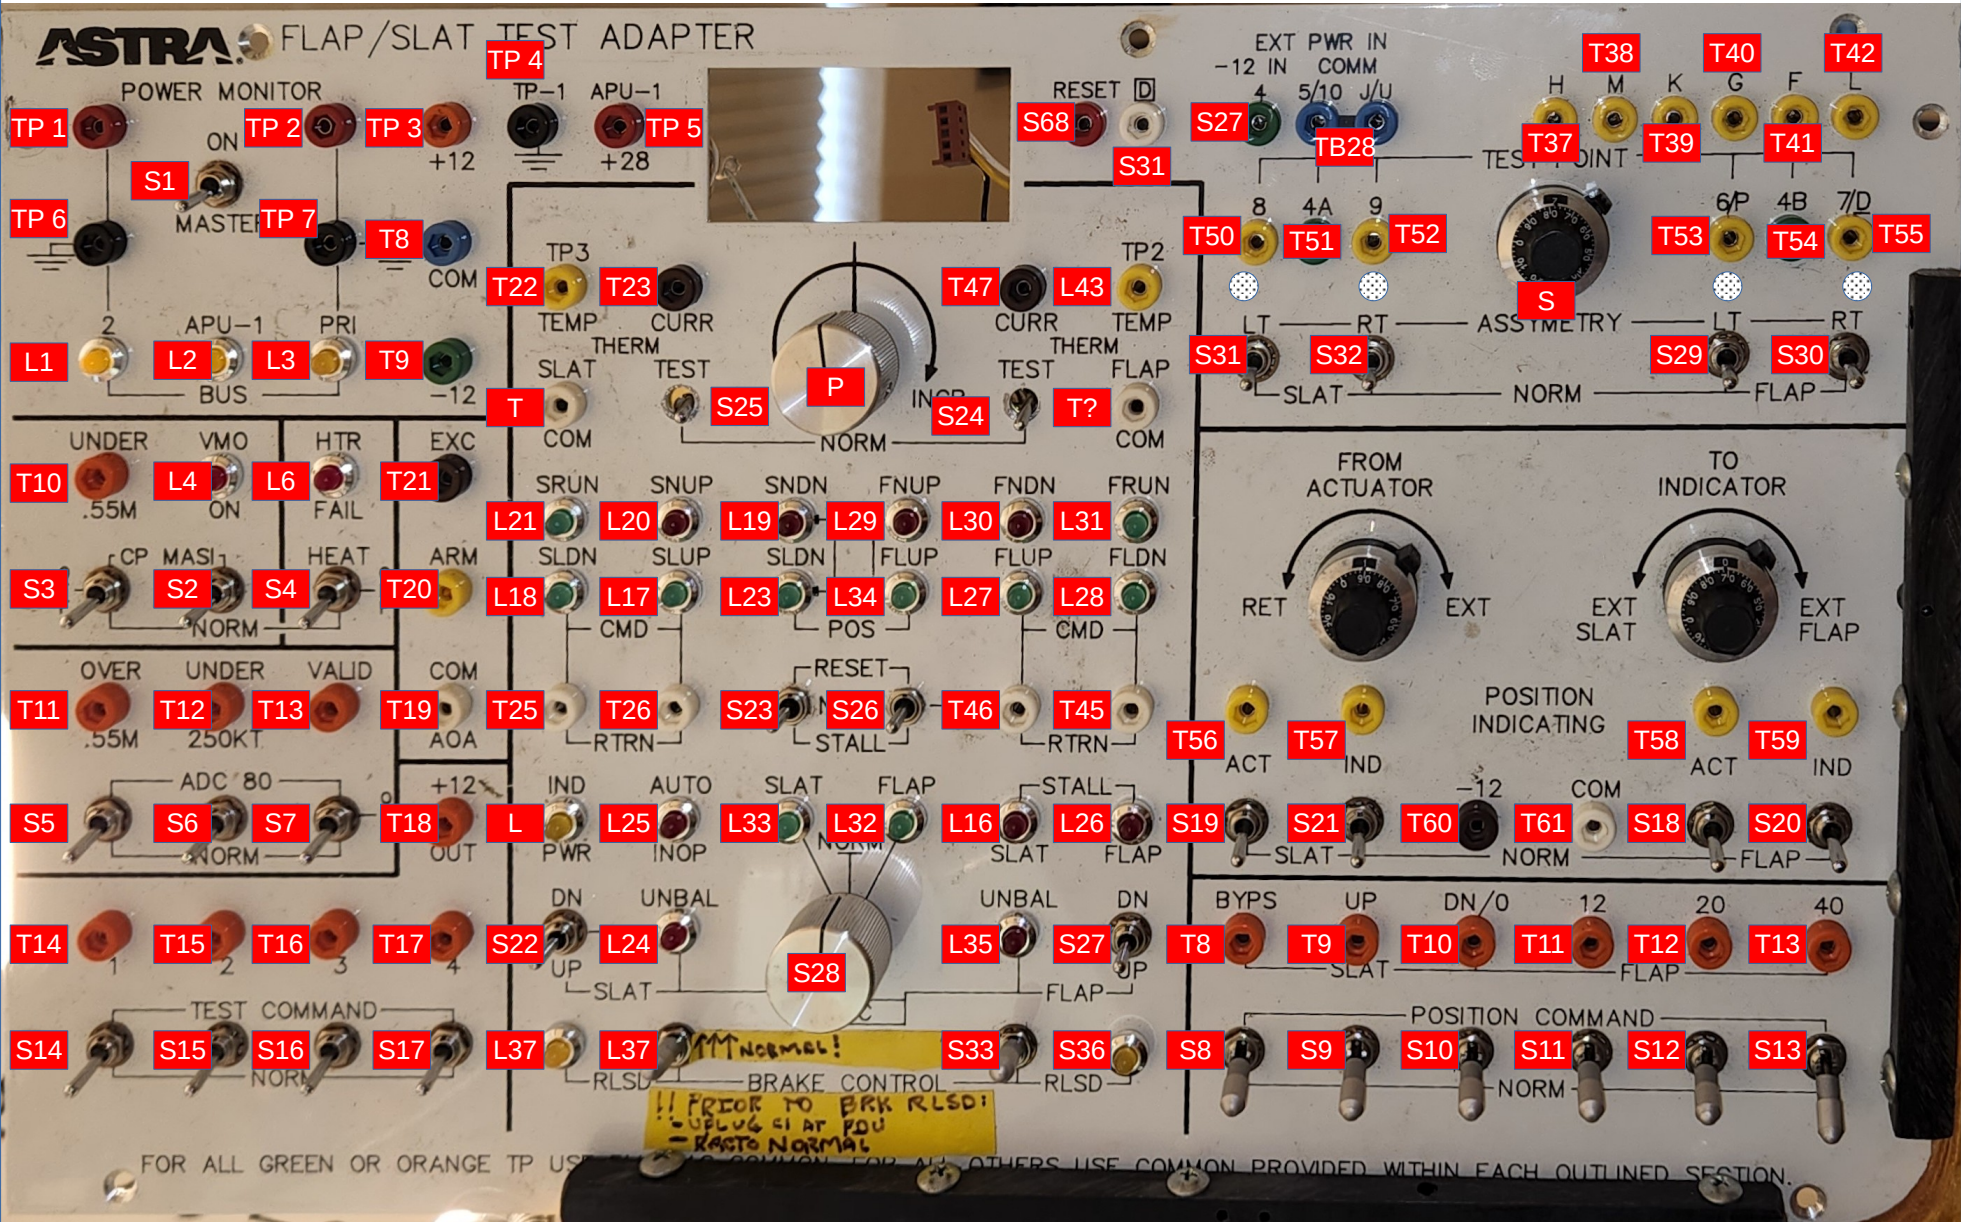
| s3 | | loose |
| s13 | 0.5 | loose |

| s28 | 0.027 | upper terminal erratic |

Substituted with 3 position switch

Remove and replace 5 switches with new.  
Replaced sw s34 with new.

8 switches test high resistance.. S3, S5 s6, s7 replaced with new and rewire. Rewire T1 and T2 to Rac switch area to reduce rats nest.
