FLAP RAC CONTROL

SLAT RAC CONTROL

POWER AND GROUND ANALYSIS

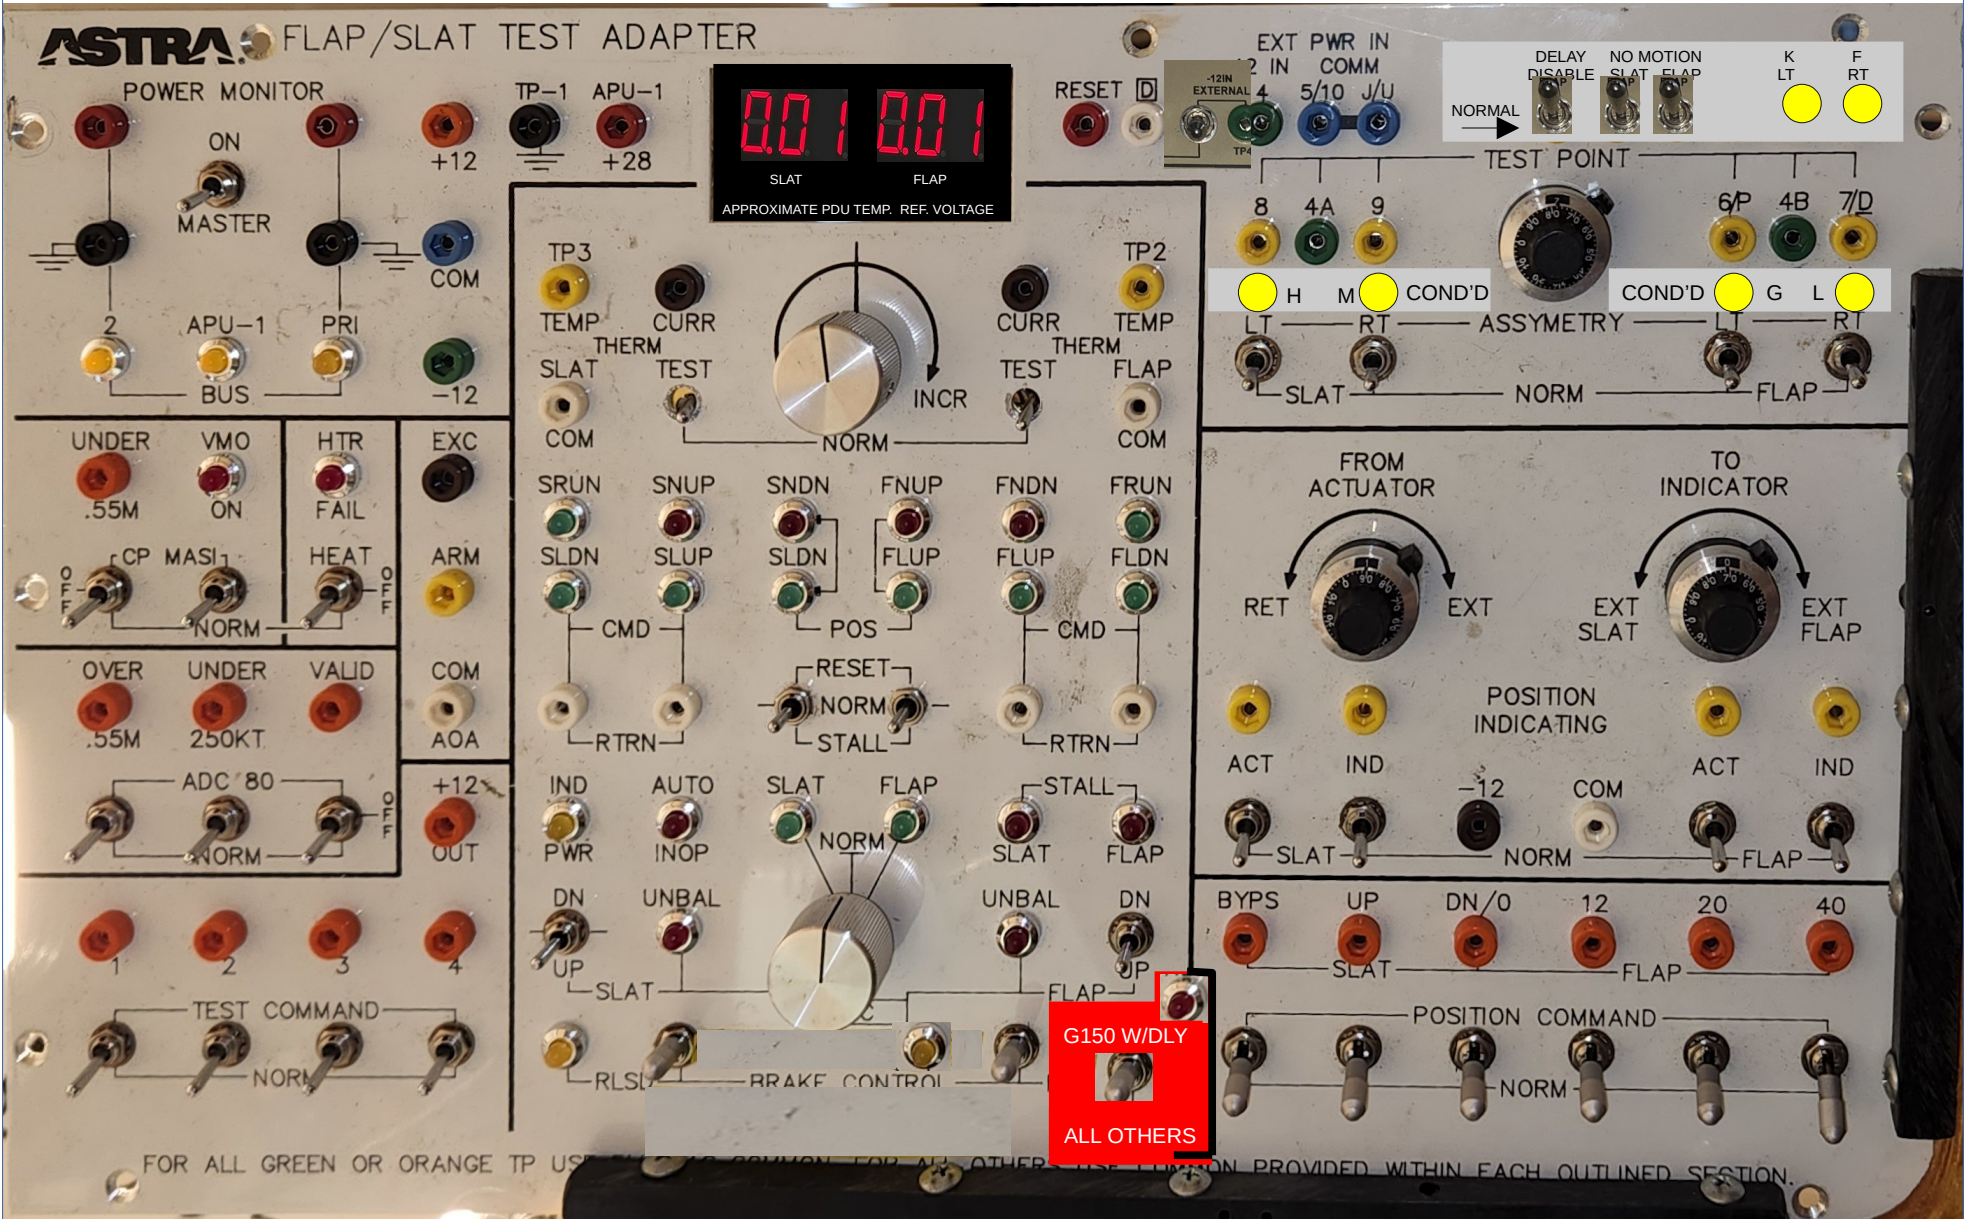
| s1 | 0.003 | |
| s3 | | loose |
| s4 | 0.004 | |
| s5 | 2 | |
| s6 | 2 | |
| s7 | 2.5 | |
| s8 | 0.02 | |
| s9 | 0.05 | |
| s10 | 0.2 | |
| s11 | 0.029 | |
| s13 | 0.5 | loose |

Substituted with 3 position switch

| s18 | 1.5 | |
| s19 | 0.008 | |
| s20 | .25 | |
| s21 | 0.008 | |
| s22 | 0.004 | |
| s23 | 0.073 | |
| s24 | .039 | |
| s25 | 0.109 | |
| s27 | 0.004 | |
| s33 | 0.002 | |
| s34 | 0.002 | |

Remove and replace 5 switches with new.  
Replaced sw s34 with new.

8 switches test high resistance.. S3, S5 s6, s7 replaced with new and rewire. Rewire T1 and T2 to Rac switch area to reduce rats nest.
